Access Compliance Report

Public Rights-of-Way

(Curb Ramps)

Intersection ID: 27841	Main Street: BALLANTYNE COUNTRY CLUB DR	Cross Street: OLD WAYSIDE RD	Location: NE
ADA ID: B1E02C6A5CBB	Ramp Type: Perp	Initial Pass/Fail: Fail	Overall Compliance: No
Severity Score: 21.25			
Codes/Mitigation Info/Possible Solution		Field Measurements/Component Compliance

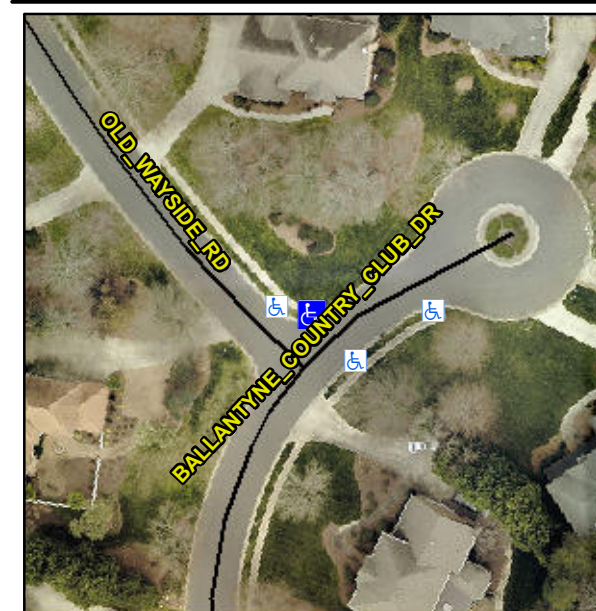
Not Found, R304.5.1, R304.5.3

Compliance	Description	Data	Compliance	Description	Data
N/A	Ramp Length (in)	48.0	Yes	Ramp Slope (%)	7.6
No	Ramp Width (in)	41.0	No	Ramp XSlope (%)	6.5
N/A	Flare Type LT	N/A	N/A	Flare Type RT	N/A
N/A	Flare Slope LT (%)	N/A	N/A	Flare Slope RT (%)	N/A
N/A	Flare Traversable LT?	N/A	N/A	Flare Traversable RT?	N/A
N/A	Landing Length (in)	N/A	N/A	DWS Provided?	N/A
N/A	Landing Width (in)	N/A	N/A	DWS Contrast?	N/A
N/A	Landing Slope (%)	N/A	N/A	DWS Length (in)	N/A
N/A	Landing X Slope (%)	N/A	N/A	DWS Full Width?	N/A
N/A	Landing Curb? (Y/N)	N/A	N/A	DWS Offset (in)	N/A
N/A	Shared Landing?	N/A			
N/A	Gutter Ponding?	N/A	N/A	Gutter Slope (%)	N/A
N/A	Gutter Lip Ht (in)	N/A	N/A	Gutter X Slope (%)	N/A
N/A	Painted X Walk1?	No	N/A	Painted X Walk2?	N/A
	X Walk 1 Direction	To SE		X Walk 2 Direction	N/A
N/A	X Walk 1 Width (in)	N/A	N/A	X Walk 2 Width (in)	N/A
	X Walk 1 Slope (%)	0.3		X Walk 2 Slope (%)	N/A
	X Walk 1 X Slope (%)	3.8		X Walk 2 X Slope (%)	N/A

N/A	Ramp inside XWalk1?	N/A	N/A	Ramp inside XWalk2?	N/A
	Road Slope (%)	N/A	N/A	Clear Space?	N/A
	Road X Slope (%)	N/A	N/A	Clear Space to XWalk (in)	N/A
N/A	Any Obstructions?	N/A	N/A	Storm Grate/Utility Hazard?	N/A
	Obstruction Type			Storm Grate/Utility Type	
		N/A			N/A
			Yes	Surface Condition? (G/P)	Good

Remove & Replace Entire Ramp.
