Access Compliance Report Public Rights-of-Way (Curb Ramps)

Intersection ID: 13749	Main Street: BARRINGER_DR	Cross Street: REMOUNT_RD	Location: NW
ADA ID: B1E515157229	Ramp Type: PerpDiag	Initial Pass/Fail: Fail	Overall Compliance: No Severity Score: 13.75

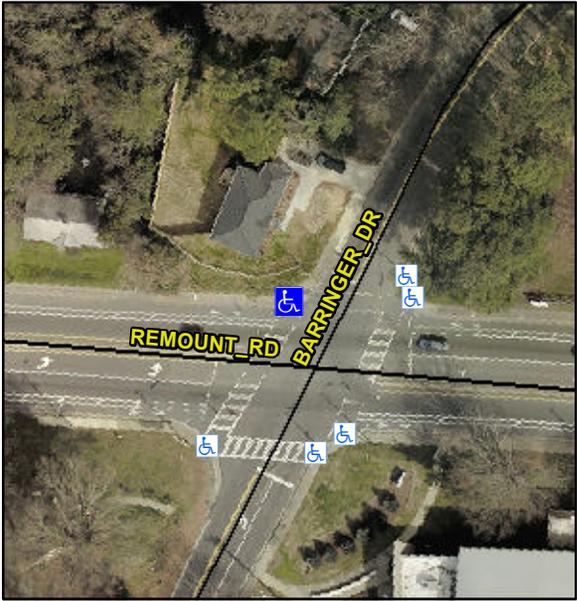
PROW/ADA:
Not Found, R304.2.2, R304.5.3

Compliance	Description	Data	Compliance	Description	Data
N/A	Ramp Length (in)	58.0	No	Ramp Slope (%)	10.0
Yes	Ramp Width (in)	60.0	No	Ramp XSlope (%)	3.4
N/A	Flare Type LT	N/A	N/A	Flare Type RT	N/A
N/A	Flare Slope LT (%)	N/A	N/A	Flare Slope RT (%)	N/A
N/A	Flare Traversable LT?	N/A	N/A	Flare Traversable RT?	N/A
N/A	Landing Length (in)	N/A	N/A	DWS Provided?	N/A
N/A	Landing Width (in)	N/A	N/A	DWS Contrast?	N/A
N/A	Landing Slope (%)	N/A	N/A	DWS Length (in)	N/A
N/A	Landing X Slope (%)	N/A	N/A	DWS Full Width?	N/A
N/A	Landing Curb? (Y/N)	N/A	N/A	DWS Offset (in)	N/A
N/A	Shared Landing?	N/A			
N/A	Gutter Ponding?	N/A	N/A	Gutter Slope (%)	N/A
N/A	Gutter Lip Ht (in)	N/A	N/A	Gutter X Slope (%)	N/A
N/A	Painted X Walk1?	Yes	N/A	Painted X Walk2?	Yes
	X Walk 1 Direction	To SW		X Walk 2 Direction	To E
N/A	X Walk 1 Width (in)	112.0	N/A	X Walk 2 Width (in)	114.0
	X Walk 1 Slope (%)	2.6		X Walk 2 Slope (%)	1.8
	X Walk 1 X Slope (%)	1.8		X Walk 2 X Slope (%)	2.0

N/A	Ramp inside XWalk1?	No	N/A	Ramp inside XWalk2?	Yes
	Road Slope (%)	0.1	N/A	Clear Space?	N/A
	Road X Slope (%)	2.5	N/A	Clear Space to XWalk (in)	N/A
N/A	Any Obstructions?	N/A	N/A	Storm Grate/Utility Hazard?	N/A
	Obstruction Type			Storm Grate/Utility Type	
		N/A			N/A
			Yes	Surface Condition? (G/P)	Good

Possible Solutions:
Remove & Replace Curb Ramp With Two New Directional Ramps or Equivalent. Restripe Crosswalk.
