Access Compliance Report

Public Rights-of-Way

(Curb Ramps)

| Intersection ID: 15796 | Main Street: SNOW_LN | Cross Street: IDLEWILD_RD_NORTH | Location: SW |

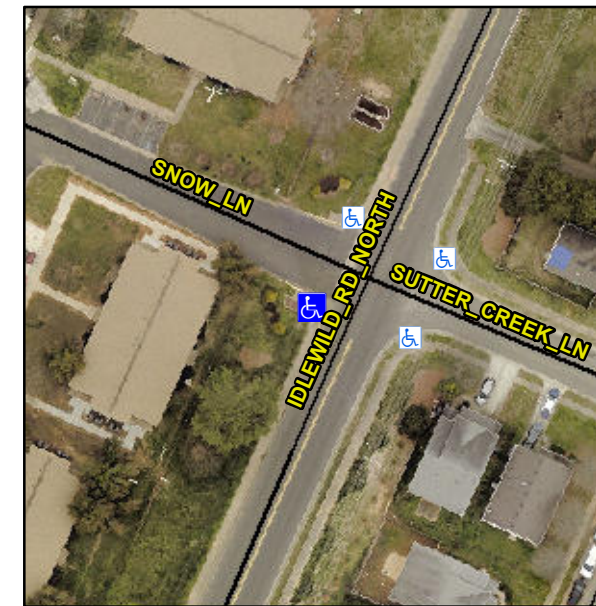
Not Found, R304.2.2, R304.5.3

| Compliance | Description | Data | Compliance | Description | Data |
|---|---|---|---|---|---|
| N/A | Ramp Length (in) | 59.0 | No | Ramp Slope (%) | 8.9 |
| Yes | Ramp Width (in) | 48.0 | No | Ramp XSlope (%) | 6.7 |

Remove & Replace Curb Ramp With Two New Directional Ramps or Equivalent.
