# Access Compliance Report

## Public Rights-of-Way

### (Curb Ramps)

Intersection ID: 14373	Main Street: EAST_BV	Cross Street: LYNDHURST_AV	Location: SW
ADA ID: B1F8745DF616	Ramp Type: Perp	Initial Pass/Fail: Fail	Overall Compliance: No
Severity Score: 13.75			
Codes/Mitigation Info/Possible Solution		Field Measurements/Component Compliance

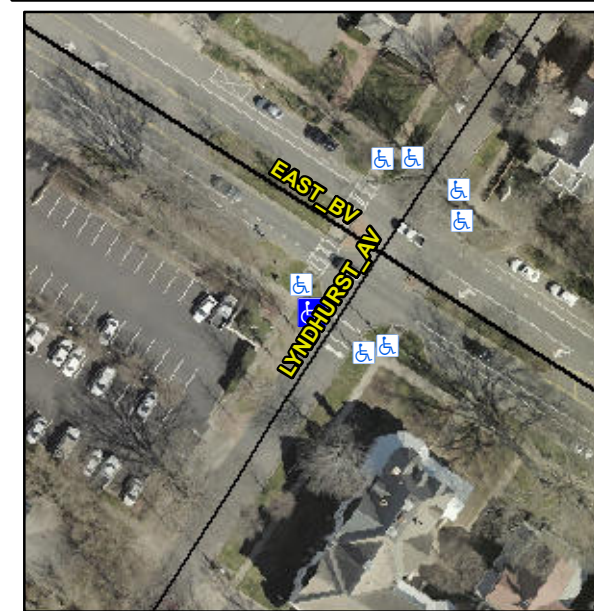
**Not Found, R304.2.2, R304.5.3**

Compliance	Description	Data	Compliance	Description	Data
N/A	Ramp Length (in)	80.0	No	Ramp Slope (%)	9.1
Yes	Ramp Width (in)	71.0	No	Ramp XSlope (%)	2.6
N/A	Flare Type LT	N/A	N/A	Flare Type RT	N/A
N/A	Flare Slope LT (%)	N/A	N/A	Flare Slope RT (%)	N/A
N/A	Flare Traversable LT?	N/A	N/A	Flare Traversable RT?	N/A
N/A	Landing Length (in)	N/A	N/A	DWS Provided?	N/A
N/A	Landing Width (in)	N/A	N/A	DWS Contrast?	N/A
N/A	Landing Slope (%)	N/A	N/A	DWS Length (in)	N/A
N/A	Landing X Slope (%)	N/A	N/A	DWS Full Width?	N/A
N/A	Landing Curb? (Y/N)	N/A	N/A	DWS Offset (in)	N/A
N/A	Shared Landing?	N/A			
N/A	Gutter Ponding?	N/A	N/A	Gutter Slope (%)	N/A
N/A	Gutter Lip Ht (in)	N/A	N/A	Gutter X Slope (%)	N/A
N/A	Painted X Walk1?	Yes	N/A	Painted X Walk2?	N/A
	X Walk 1 Direction	To SE		X Walk 2 Direction	N/A
N/A	X Walk 1 Width (in)	110.0	N/A	X Walk 2 Width (in)	N/A
	X Walk 1 Slope (%)	5.0		X Walk 2 Slope (%)	N/A
	X Walk 1 X Slope (%)	2.7		X Walk 2 X Slope (%)	N/A

N/A	Ramp inside XWalk1?	Yes	N/A	Ramp inside XWalk2?	N/A
	Road Slope (%)	N/A	N/A	Clear Space?	N/A
	Road X Slope (%)	N/A	N/A	Clear Space to XWalk (in)	N/A
N/A	Any Obstructions?	N/A	N/A	Storm Grate/Utility Hazard?	N/A
	Obstruction Type			Storm Grate/Utility Type	
		N/A			N/A
			Yes	Surface Condition? (G/P)	Good

**Remove & Replace Entire Ramp.**
