# Access Compliance Report

## Public Rights-of-Way

### (Curb Ramps)

Intersection ID: 21560	Main Street: RITTENHOUSE_CR	Cross Street: SARDIS_RD_NORTH	Location: SW
ADA ID: B20A897F7293	Ramp Type: PerpDiag	Initial Pass/Fail: Fail	Overall Compliance: No
			Severity Score: 41.25

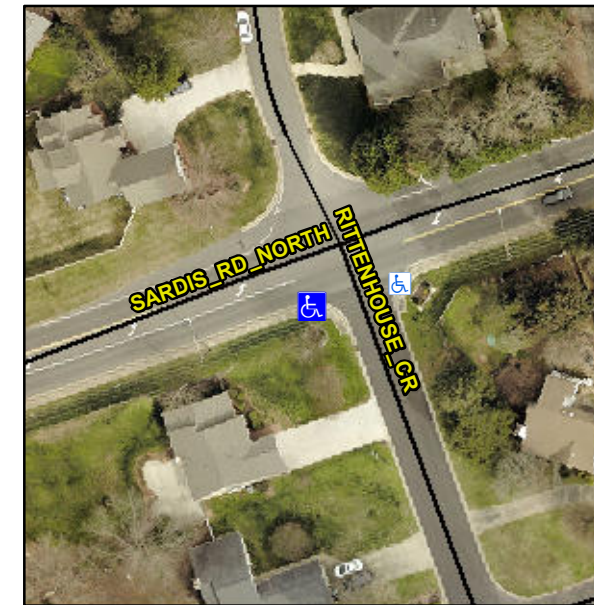
**Not Found, R304.2.2, R304.5.3, R302.7**

Compliance	Description	Data	Compliance	Description	Data
N/A	Ramp Length (in)	48.0	No	Ramp Slope (%)	14.9
Yes	Ramp Width (in)	48.0	No	Ramp XSlope (%)	2.2
N/A	Flare Type LT	N/A	N/A	Flare Type RT	N/A
N/A	Flare Slope LT (%)	N/A	N/A	Flare Slope RT (%)	N/A
N/A	Flare Traversable LT?	N/A	N/A	Flare Traversable RT?	N/A
N/A	Landing Length (in)	N/A	N/A	DWS Provided?	N/A
N/A	Landing Width (in)	N/A	N/A	DWS Contrast?	N/A
N/A	Landing Slope (%)	N/A	N/A	DWS Length (in)	N/A
N/A	Landing X Slope (%)	N/A	N/A	DWS Full Width?	N/A
N/A	Landing Curb? (Y/N)	N/A	N/A	DWS Offset (in)	N/A
N/A	Shared Landing?	N/A			
N/A	Gutter Ponding?	N/A	N/A	Gutter Slope (%)	N/A
N/A	Gutter Lip Ht (in)	N/A	N/A	Gutter X Slope (%)	N/A
N/A	Painted X Walk1?	No	N/A	Painted X Walk2?	No
	X Walk 1 Direction	To E		X Walk 2 Direction	To N
N/A	X Walk 1 Width (in)	N/A	N/A	X Walk 2 Width (in)	N/A
	X Walk 1 Slope (%)	2.7		X Walk 2 Slope (%)	6.3
	X Walk 1 X Slope (%)	5.1		X Walk 2 X Slope (%)	1.6

N/A	Ramp inside XWalk1?	N/A	N/A	Ramp inside XWalk2?	N/A
	Road Slope (%)	3.1	N/A	Clear Space?	N/A
	Road X Slope (%)	3.9	N/A	Clear Space to XWalk (in)	N/A
N/A	Any Obstructions?	N/A	N/A	Storm Grate/Utility Hazard?	N/A
	Obstruction Type			Storm Grate/Utility Type	
		N/A			N/A
		No		Surface Condition? (G/P)	Poor

**Remove & Replace Curb Ramp With Two New Directional Ramps or Equivalent.**

Total Cost: \$ 3200.00
