Access Compliance Report

Public Rights-of-Way

(Curb Ramps)

Intersection ID: 23329	Main Street: GLENEAGLES_RD	Cross Street: PARK_RD	Location: NE
ADA ID: B20B7F3282FB	Ramp Type: PerpDiag	Initial Pass/Fail: Fail	Overall Compliance: No
Codes/Mitigation Info/Possible Solution		Field Measurements/Component Compliance	
Severity Score: 33.75

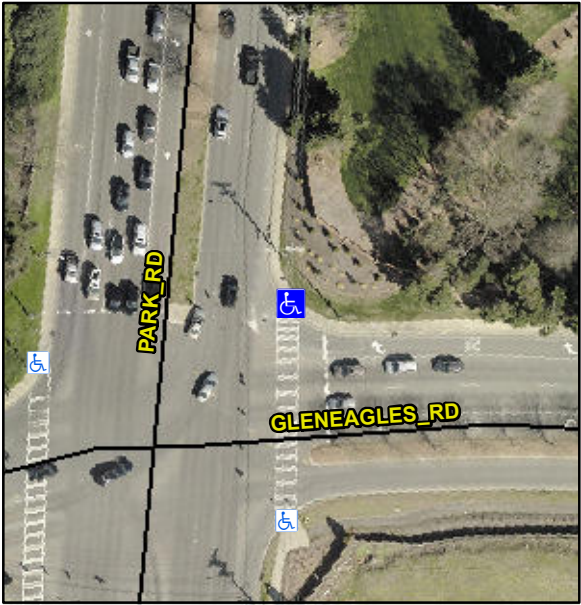
Possible Solutions:	Compliance	Description	Data	Compliance	Description	Data
	Remove & Replace Curb Ramp With Two New Directional Ramps or Equivalent.	N/A	Ramp Length (in)	58.0	No	Ramp Slope (%)	12.2
		No	Ramp Width (in)	36.0	Yes	Ramp XSlope (%)	0.4
		N/A	Flare Type LT	N/A	N/A	Flare Type RT	N/A
		N/A	Flare Slope LT (%)	N/A	N/A	Flare Slope RT (%)	N/A
		N/A	Flare Traversable LT?	N/A	N/A	Flare Traversable RT?	N/A
		N/A	Landing Length (in)	N/A	N/A	DWS Provided?	N/A
		N/A	Landing Width (in)	N/A	N/A	DWS Contrast?	N/A
		N/A	Landing Slope (%)	N/A	N/A	DWS Length (in)	N/A
		N/A	Landing X Slope (%)	N/A	N/A	DWS Full Width?	N/A
<p>Surveyor Notes:</p> <p>N/A</p> <p>PROW/ADA:</p> <p>R304.5.1, R304.2.2</p>		N/A	Landing Curb? (Y/N)	N/A	N/A	DWS Offset (in)	N/A
		N/A	Shared Landing?	N/A			
		N/A	Gutter Ponding?	N/A	N/A	Gutter Slope (%)	N/A
		N/A	Gutter Lip Ht (in)	N/A	N/A	Gutter X Slope (%)	N/A
		N/A	Painted X Walk1?	No	N/A	Painted X Walk2?	Yes

X Walk 1 Direction	To SW		X Walk 2 Direction	To S
		N/A	X Walk 1 Width (in)	N/A	N/A	X Walk 2 Width (in)	123.0
			X Walk 1 Slope (%)	3.3		X Walk 2 Slope (%)	2.0
			X Walk 1 X Slope (%)	0.6		X Walk 2 X Slope (%)	1.9
		N/A	Ramp inside XWalk1?	N/A	N/A	Ramp inside XWalk2?	Yes
<p>Street 1 Name</p> <p>Stop Condition-Street 2</p> <p>Street 2 Name</p> <p>Stop Condition-Street 1</p>			Road Slope (%)	2.8	N/A	Clear Space?	N/A
			Road X Slope (%)	0.7	N/A	Clear Space to XWalk (in)	N/A
		N/A	Any Obstructions?	N/A	N/A	Storm Grate/Utility Hazard?	N/A
			Obstruction Type			Storm Grate/Utility Type	
					N/A		N/A
					Yes	Surface Condition? (G/P)	Good
Total Cost:		\$	3200.00
