Access Compliance Report Public Rights-of-Way (Curb Ramps)

Intersection ID: 40044004 Main St		Crease Street	- NI/A			Lessier	14/
Intersection ID: 10011864 Main Str	ection ID: 10011864 Main Street: MARYANNA_CT		Cross Street: N/A			Location:	W
ADA ID: B21796E77B25 Ramp Type: Perp		Initial Pass/Fail: Fail Overall Compliance: No			o Severity Score:	10	
Codes/Mitigation Info/Possible Solution		Field Measurements/Component Compliance

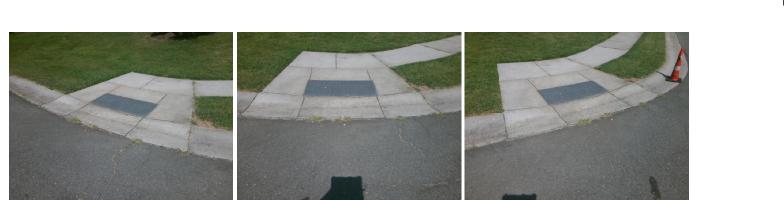
5. S	Possible Solutions:	Compliance Description Data		Data	Compliance Description		Data
	Remove & Replace Entire Ramp.	N/A	Ramp Length (in)	49.0	Yes	Ramp Slope (%)	5.5
6		No	Ramp Width (in)	46.0	No	Ramp XSlope (%)	3.4
the second second	8	N/A	Flare Type LT	N/A	N/A	Flare Type RT	N/A
		N/A	Flare Slope LT (%)	N/A	N/A	Flare Slope RT (%)	N/A
		N/A	Flare Traversable LT?	N/A	N/A	Flare Traversable RT?	N/A
CON 19 1 1 1 1 1 1 1 1 1 1 1 1 1 1 1 1 1 1		N/A	Landing Length (in)	N/A	N/A	DWS Provided?	N/A
State and an and a state of the	Surveyor Notes:	N/A	Landing Width (in)	N/A	N/A	DWS Contrast?	N/A
	N/A	N/A	Landing Slope (%)	N/A	N/A	DWS Length (in)	N/A
		N/A	Landing X Slope (%)	N/A	N/A	DWS Full Width?	N/A
a to The Provent		N/A	Landing Curb? (Y/N)	N/A	N/A	DWS Offset (in)	N/A
		N/A	Shared Landing?	N/A			
	PROW/ADA:	N/A	Gutter Ponding?	N/A	N/A	Gutter Slope (%)	N/A
and the second s	Not Found, R304.5.1, R304.5.3	N/A	Gutter Lip Ht (in)	N/A	N/A	Gutter X Slope (%)	N/A
