Access Compliance Report Public Rights-of-Way (Curb Ramps)

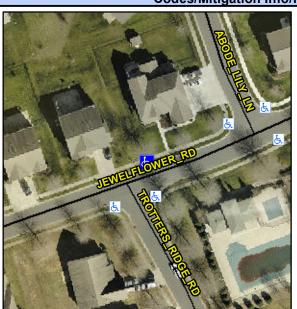
Intersection ID: 15439Main Street: TROTTERS_RIDGE_RDCross Street: JEWELFLOWER_RDLocation:NEADA ID: B240B866DFC6Ramp Type: PerpInitial Pass/Fail: FailOverall Compliance: NoSeverity Score: 21.25

Not Found, R304.5.1, R304.2.2

Field Measurements/Component Compliance							
Comp	oliance Description	Data	Comp	oliance Description	Data		
N/A	Ramp Length (in)	48.5	No	Ramp Slope (%)	9.6		
No	Ramp Width (in)	46.5	Yes	Ramp XSlope (%)	1.9		
N/A	Flare Type LT	N/A	N/A	Flare Type RT	N/A		
N/A	Flare Slope LT (%)	N/A	N/A	Flare Slope RT (%)	N/A		
N/A	Flare Traversable LT?	N/A	N/A	Flare Traversable RT?	N/A		
N/A	Landing Length (in)	N/A	N/A	DWS Provided?	N/A		
N/A	Landing Width (in)	N/A	N/A	DWS Contrast?	N/A		
N/A	Landing Slope (%)	N/A	N/A	DWS Length (in)	N/A		
N/A	Landing X Slope (%)	N/A	N/A	DWS Full Width?	N/A		
N/A	Landing Curb? (Y/N)	N/A	N/A	DWS Offset (in)	N/A		
N/A	Shared Landing?	N/A					
N/A	Gutter Ponding?	N/A	N/A	Gutter Slope (%)	N/A		
N/A	Gutter Lip Ht (in)	N/A	N/A	Gutter X Slope (%)	N/A		
N/A	Painted X Walk1?	No	N/A	Painted X Walk2?	N/A		
	X Walk 1 Direction	To S		X Walk 2 Direction	N/A		
N/A	X Walk 1 Width (in)	N/A	N/A	X Walk 2 Width (in)	N/A

X Walk 1 Slope (%)	3.8		X Walk 2 Slope (%)	N/A		
	X Walk 1 X Slope (%)	2.6		X Walk 2 X Slope (%)	N/A		
N/A	Ramp inside XWalk1?	N/A	N/A	Ramp inside XWalk2?	N/A		
	Road Slope (%)	N/A	N/A	Clear Space?	N/A		
	Road X Slope (%)	N/A	N/A	Clear Space to XWalk (in)	N/A		
N/A	Any Obstructions?	N/A	N/A	Storm Grate/Utility Hazard?	N/A		
	Obstruction Type		l	Storm Grate/Utility Type			
		N/A			N/A		
			Yes	Surface Condition? (G/P)	Good

Remove & Replace Entire Ramp.
