## Access Compliance Report Public Rights-of-Way (Curb Ramps)

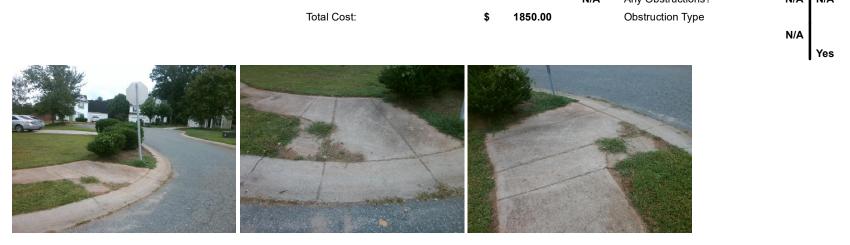
Interpretion ID: 12167	Arrestion ID: 12167 Main Street: SUNNVEIELD OT								e
Intersection ID: 12167		Main Street: SUNNYFIELD_CT			Cross Street: TIGER_LILY_LN			Location:	S
ADA ID: B256DFB3C16A	256DFB3C16A Ramp Type: Perp			Initial Pass/Fail: Fail Overall Compliance: No			o Severity Score:	10	
Codes/Mitigation Info/Possible Solution				Field Measurements/Component Compliance					
	-4	Possible Solutions:		Compliance Description			Data Compliance Description		
		Remove & Replace	e Entire Ramp.	N/A	Ramp Length (in)	51.5	Yes	Ramp Slope (%)	5.3

- I I II	×		-	No	Ramp Width (in)	39.5	No	Ramp XSlope (%)	2.2
				N/A	Flare Type LT	N/A	N/A	Flare Type RT	N/A
	A 12 4.			N/A	Flare Slope LT (%)	N/A	N/A	Flare Slope RT (%)	N/A
and the second s	and the			N/A	Flare Traversable LT?	N/A	N/A	Flare Traversable RT?	N/A
A LEBRA				N/A	Landing Length (in)	N/A	N/A	DWS Provided?	N/A
	200	Surveyor Notes:		N/A	Landing Width (in)	N/A	N/A	DWS Contrast?	N/A
		N/A		N/A	Landing Slope (%)	N/A	N/A	DWS Length (in)	N/A
	the state			N/A	Landing X Slope (%)	N/A	N/A	DWS Full Width?	N/A
	and a			N/A	Landing Curb? (Y/N)	N/A	N/A	DWS Offset (in)	N/A
		N/A	Shared Landing?	N/A					
		PROW/ADA:		N/A	Gutter Ponding?	N/A	N/A	Gutter Slope (%)	N/A
THERE IS A	And B	Not Found, R304.	5.1, R304.5.3	N/A	Gutter Lip Ht (in)	N/A	N/A	Gutter X Slope (%)	N/A
	Carlos Carlos	, ,	,	N/A	Painted X Walk1?	No	N/A	Painted X Walk2?	N/A
Chemin 1411				X Walk 1 Direction	To NW		X Walk 2 Direction	N/A	
			N/A	X Walk 1 Width (in)	N/A	N/A	X Walk 2 Width (in)	N/A

Street 1 Name	SUNNYFIELD CT				X Walk 1 Slope (%)	2.5		X Walk 2 Slope (%)	N/A
Stop Condition-Street 2	StopSign				X Walk 1 X Slope (%)	0.2		X Walk 2 X Slope (%)	N/A
Street 2 Name	N/A			N/A	Ramp inside XWalk1?	N/A	N/A	Ramp inside XWalk2?	N/A
Stop Condition-Street 1	N/A				Road Slope (%)	N/A	N/A	Clear Space?	N/A
					Road X Slope (%)	N/A	N/A	Clear Space to XWalk (in)	N/A
				N/A	Any Obstructions?	N/A	N/A	Storm Grate/Utility Hazard?	N/A
		Total Cost:	\$ 18	850.00	Obstruction Type			Storm Grate/Utility Type	
						N/A			N/A
