Access Compliance Report

Public Rights-of-Way

(Curb Ramps)

Intersection ID: 14959	Main Street: REDDMAN_RD	Cross Street: CENTRAL_AV	Location: S
ADA ID: B25E894C4258	Ramp Type: PerpDiag	Initial Pass/Fail: Fail	Overall Compliance: No
		Severity Score: 10

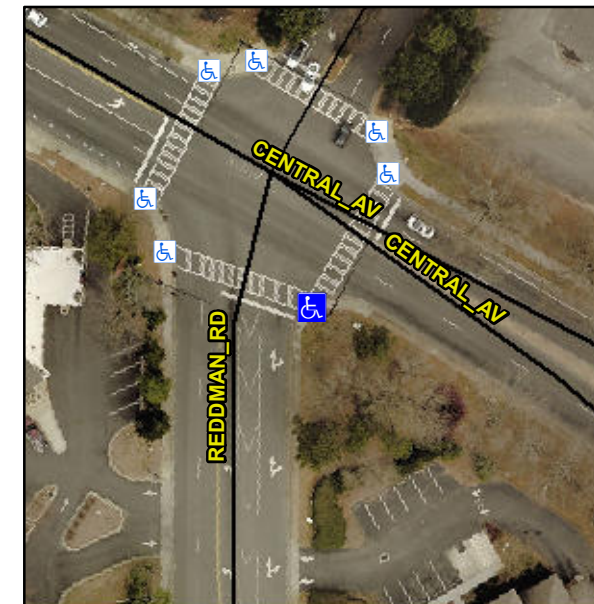
Not Found, R304.5.1

Compliance	Description	Data	Compliance	Description	Data
N/A	Ramp Length (in)	59.5	Yes	Ramp Slope (%)	7.7
No	Ramp Width (in)	47.5	Yes	Ramp XSlope (%)	3.9
N/A	Flare Type LT	N/A	N/A	Flare Type RT	N/A
N/A	Flare Slope LT (%)	N/A	N/A	Flare Slope RT (%)	N/A
N/A	Flare Traversable LT?	N/A	N/A	Flare Traversable RT?	N/A
N/A	Landing Length (in)	N/A	N/A	DWS Provided?	N/A
N/A	Landing Width (in)	N/A	N/A	DWS Contrast?	N/A
N/A	Landing Slope (%)	N/A	N/A	DWS Length (in)	N/A
N/A	Landing X Slope (%)	N/A	N/A	DWS Full Width?	N/A
N/A	Landing Curb? (Y/N)	N/A	N/A	DWS Offset (in)	N/A
N/A	Shared Landing?	N/A			
N/A	Gutter Ponding?	N/A	N/A	Gutter Slope (%)	N/A
N/A	Gutter Lip Ht (in)	N/A	N/A	Gutter X Slope (%)	N/A
N/A	Painted X Walk1?	Yes	N/A	Painted X Walk2?	Yes
	X Walk 1 Direction	To NE		X Walk 2 Direction	To NW
N/A	X Walk 1 Width (in)	110.5	N/A	X Walk 2 Width (in)	109.5
	X Walk 1 Slope (%)	1.4		X Walk 2 Slope (%)	6.5
	X Walk 1 X Slope (%)	6.4		X Walk 2 X Slope (%)	0.4

N/A	Ramp inside XWalk1?	Yes	N/A	Ramp inside XWalk2?	Yes
	Road Slope (%)	4.4	N/A	Clear Space?	N/A
	Road X Slope (%)	5.0	N/A	Clear Space to XWalk (in)	N/A
N/A	Any Obstructions?	N/A	N/A	Storm Grate/Utility Hazard?	N/A
	Obstruction Type			Storm Grate/Utility Type	
		N/A			N/A
		Yes		Surface Condition? (G/P)	Good

Remove & Replace Curb Ramp With Two New Directional Ramps or Equivalent.
