Access Compliance Report

Public Rights-of-Way

(Curb Ramps)

Intersection ID: 11838		Main Street: MECKLENBURG_AV		Cross Street: FORT_ST		Location: NE			
ADA ID: B26293AF8FB9		Ramp Type: Directional1		Initial Pass/Fail: Fail		Overall Compliance: No		Severity Score: 1.25	
Codes/Mitigation Info/Possible Solution				Field Measurements/Component Compliance					
<div>

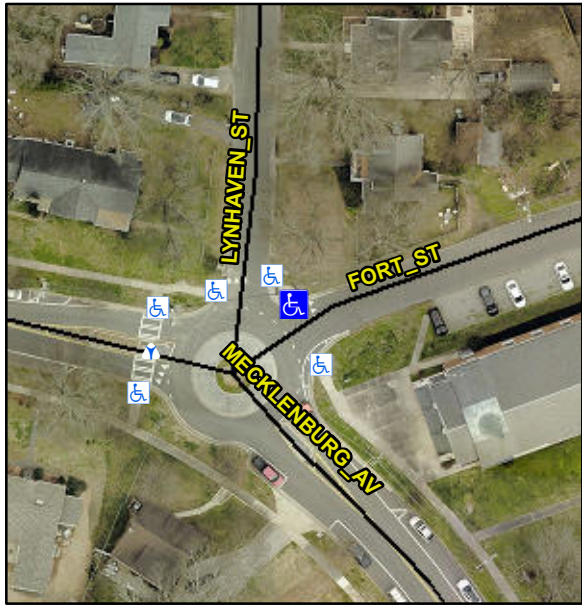
</div> <div>Possible Solutions: Remove & Replace Entire Ramp.</div> <div>Surveyor Notes: N/A</div> <div>PROW/ADA: R304.5.3</div> <div>Street 1 Name FORT ST</div> <div>Stop Condition-Street 1 YieldSign</div> <div>Street 2 Name N/A</div> <div>Stop Condition-Street 2 N/A</div> <div>Total Cost: \$ 1600.00</div>				Compliance	Description	Data	Compliance	Description	Data
				N/A	Ramp Length (in)	65.0	N/A	Grade Break?	N/A
				Yes	Ramp Width (in)	56.0	N/A	Grade Break Slope (%)	0.0
				Yes	Ramp Slope (%)	5.2	N/A	Grade Break XSlope (%)	0.0
				No	Ramp XSlope (%)	2.1			
				N/A	Flare Type LT	N/A	N/A	Flare Type RT	N/A

N/A	Flare Slope LT (%)	N/A	N/A	Flare Slope RT (%)	0.0
				N/A	Flare Traversable LT?	N/A	N/A	Flare Traversable RT?	N/A
				N/A	Landing Length (in)	0.0	N/A	DWS Provided?	N/A
				N/A	Landing Width (in)	0.0	N/A	DWS Contrast?	N/A
				N/A	Landing Slope (%)	0.0	N/A	DWS Length (in)	N/A
				N/A	Landing X Slope (%)	0.0	N/A	DWS Full Width?	N/A
				N/A	Landing Curb? (Y/N)	N/A	N/A	DWS Offset LT (in)	N/A
				N/A	Shared Landing?	N/A	N/A	DWS Offset RT (in)	N/A
				N/A	Gutter Ponding?	0.0	N/A	Gutter Slope (%)	N/A
				N/A	Gutter Lip Ht (in)	0.0	N/A	Gutter X Slope (%)	N/A
				N/A	Painted X Walk1?	No		Road Slope (%)	1.1
					X Walk 1 Direction	To SE		Road X Slope (%)	1.0
					X Walk 1 Width (in)	N/A		Clear Space?	N/A
					X Walk 1 Slope (%)	1.1	N/A	Clear Space to XWalk (in)	N/A
					X Walk 1 X Slope (%)	1.0	N/A	Storm Grate/Utility Hazard?	N/A
				N/A	Ramp inside XWalk1?	N/A		Storm Grate/Utility Type	
				N/A	Any Obstructions?	N/A			N/A

Obstruction Type		Yes	Surface Condition? (G/P)	Good
							N/A	Curb Slope (%)	8.1
