# Access Compliance Report

## Public Rights-of-Way

### (Curb Ramps)

Intersection ID: 10027508	Main Street: GRANDIFLORA_DR	Cross Street: N/A	Location: SE
ADA ID: B263CEB4A22E	Ramp Type: PerpDiag	Initial Pass/Fail: Fail	Overall Compliance: No
Codes/Mitigation Info/Possible Solution		Field Measurements/Component Compliance	
Severity Score: 8.75

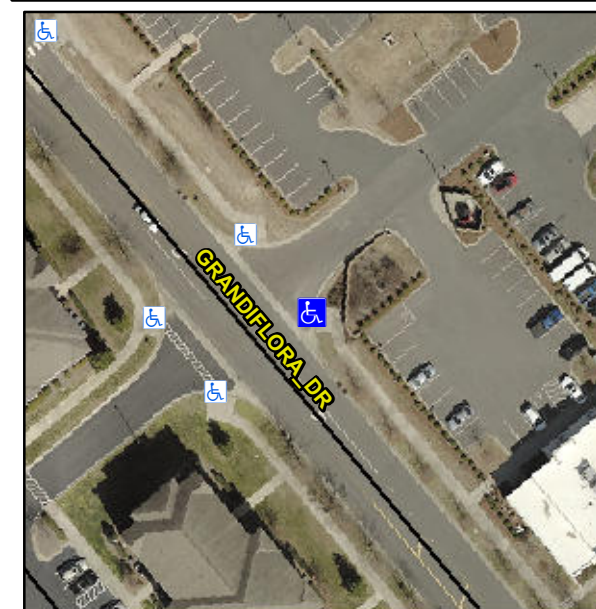
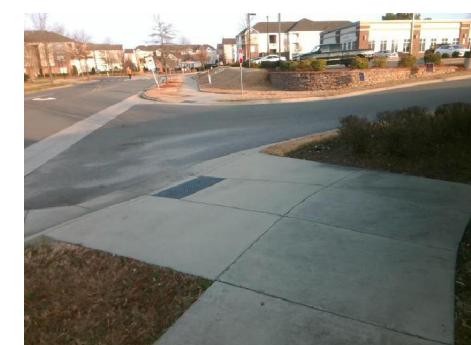
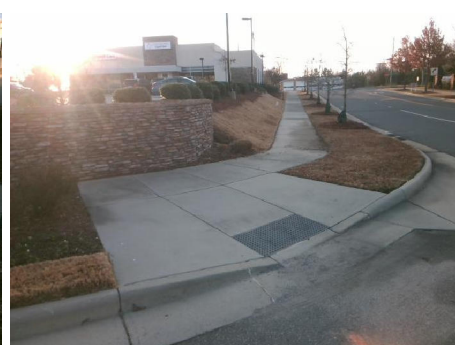
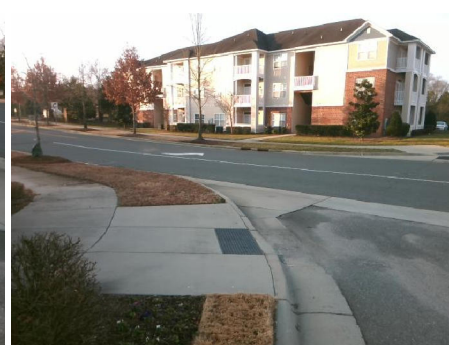
**Not Found, R304.5.1**

Compliance	Description	Data	Compliance	Description	Data
N/A	Ramp Length (in)	97.0	Yes	Ramp Slope (%)	7.7
No	Ramp Width (in)	45.0	Yes	Ramp XSlope (%)	0.6
N/A	Flare Type LT	N/A	N/A	Flare Type RT	N/A
N/A	Flare Slope LT (%)	N/A	N/A	Flare Slope RT (%)	N/A
N/A	Flare Traversable LT?	N/A	N/A	Flare Traversable RT?	N/A
N/A	Landing Length (in)	N/A	N/A	DWS Provided?	N/A
N/A	Landing Width (in)	N/A	N/A	DWS Contrast?	N/A
N/A	Landing Slope (%)	N/A	N/A	DWS Length (in)	N/A
N/A	Landing X Slope (%)	N/A	N/A	DWS Full Width?	N/A
N/A	Landing Curb? (Y/N)	N/A	N/A	DWS Offset (in)	N/A
N/A	Shared Landing?	N/A			
N/A	Gutter Ponding?	N/A	N/A	Gutter Slope (%)	N/A
N/A	Gutter Lip Ht (in)	N/A	N/A	Gutter X Slope (%)	N/A
N/A	Painted X Walk1?	No	N/A	Painted X Walk2?	No
	X Walk 1 Direction	To NW		X Walk 2 Direction	To SW
N/A	X Walk 1 Width (in)	N/A	N/A	X Walk 2 Width (in)	N/A
	X Walk 1 Slope (%)	0.8		X Walk 2 Slope (%)	1.4
	X Walk 1 X Slope (%)	0.5		X Walk 2 X Slope (%)	1.2

N/A	Ramp inside XWalk1?	N/A	N/A	Ramp inside XWalk2?	N/A
	Road Slope (%)	0.3	N/A	Clear Space?	N/A
	Road X Slope (%)	1.4	N/A	Clear Space to XWalk (in)	N/A
N/A	Any Obstructions?	N/A	N/A	Storm Grate/Utility Hazard?	N/A
	Obstruction Type			Storm Grate/Utility Type	
		N/A			N/A
			Yes	Surface Condition? (G/P)	Good

**Remove & Replace Curb Ramp With Two New Directional Ramps or Equivalent.**
