Intersection ID: 10023499	Main Street: CITY_VIEW_DR	Cross Street: N/A	Location:	NW
ADA ID: B26631143785	Ramp Type: PerpDiag	Initial Pass/Fail: Fail	Overall Compliance: No	Severity Score: 10

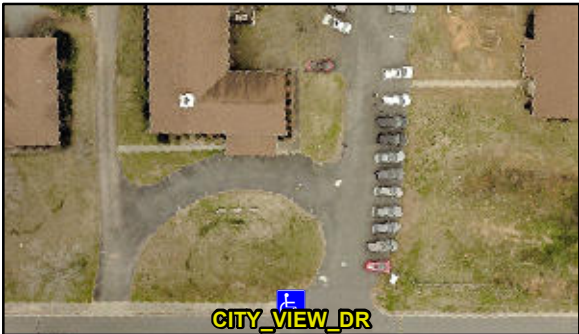
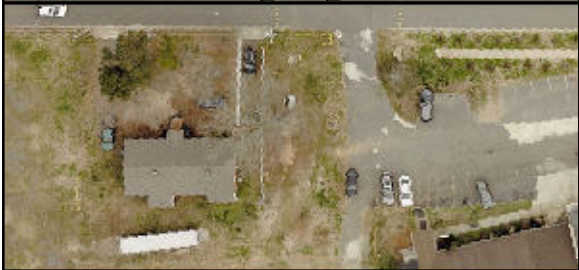
Possible Solutions:		Compliance	Description	Data	Compliance	Description	Data
	<b>Remove &amp; Replace Curb Ramp With Two New Directional Ramps or Equivalent.</b>		N/A	Ramp Length (in)	60.0	Yes	Ramp Slope (%)	6.6
			No	Ramp Width (in)	36.0	Yes	Ramp XSlope (%)	3.7
			N/A	Flare Type LT	N/A	N/A	Flare Type RT	N/A
			N/A	Flare Slope LT (%)	N/A	N/A	Flare Slope RT (%)	N/A
			N/A	Flare Traversable LT?	N/A	N/A	Flare Traversable RT?	N/A
			N/A	Landing Length (in)	N/A	N/A	DWS Provided?	N/A
			N/A	Landing Width (in)	N/A	N/A	DWS Contrast?	N/A
			N/A	Landing Slope (%)	N/A	N/A	DWS Length (in)	N/A
			N/A	Landing X Slope (%)	N/A	N/A	DWS Full Width?	N/A
Surveyor Notes:		N/A	N/A	Landing Curb? (Y/N)	N/A	N/A	DWS Offset (in)	N/A
			N/A	Shared Landing?	N/A			
PROW/ADA:		N/A	N/A	Gutter Ponding?	N/A	N/A	Gutter Slope (%)	N/A
			N/A	Gutter Lip Ht (in)	N/A	N/A	Gutter X Slope (%)	N/A

N/A	Painted X Walk1?	No	N/A	Painted X Walk2?	No
				X Walk 1 Direction	To S		X Walk 2 Direction	To E
			N/A	X Walk 1 Width (in)	N/A	N/A	X Walk 2 Width (in)	N/A
				X Walk 1 Slope (%)	0.6		X Walk 2 Slope (%)	3.8
				X Walk 1 X Slope (%)	1.8		X Walk 2 X Slope (%)	0.5
			N/A	Ramp inside XWalk1?	N/A	N/A	Ramp inside XWalk2?	N/A
				Road Slope (%)	3.8	N/A	Clear Space?	N/A
				Road X Slope (%)	2.2	N/A	Clear Space to XWalk (in)	N/A
			N/A	Any Obstructions?	N/A	N/A	Storm Grate/Utility Hazard?	N/A
				Obstruction Type			Storm Grate/Utility Type	
					N/A			N/A
						Yes	Surface Condition? (G/P)	Good
Total Cost:		\$ 3200.00
