Access Compliance Report

Public Rights-of-Way

(Curb Ramps)

Intersection ID: 12164	Main Street: SEIGLE_AV	Cross Street: BELMONT_AV	Location: W
ADA ID: B26865DF6403	Ramp Type: Perp	Initial Pass/Fail: Fail	Overall Compliance: No
Severity Score: 12.5			
Codes/Mitigation Info/Possible Solution		Field Measurements/Component Compliance

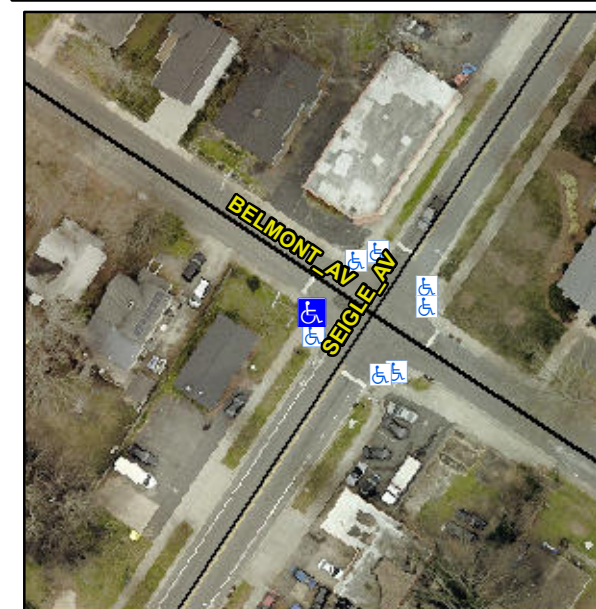
Not Found, R304.5.3

Compliance	Description	Data	Compliance	Description	Data
N/A	Ramp Length (in)	56.0	Yes	Ramp Slope (%)	6.4
Yes	Ramp Width (in)	48.0	No	Ramp XSlope (%)	5.2
N/A	Flare Type LT	N/A	N/A	Flare Type RT	N/A
N/A	Flare Slope LT (%)	N/A	N/A	Flare Slope RT (%)	N/A
N/A	Flare Traversable LT?	N/A	N/A	Flare Traversable RT?	N/A
N/A	Landing Length (in)	N/A	N/A	DWS Provided?	N/A
N/A	Landing Width (in)	N/A	N/A	DWS Contrast?	N/A
N/A	Landing Slope (%)	N/A	N/A	DWS Length (in)	N/A
N/A	Landing X Slope (%)	N/A	N/A	DWS Full Width?	N/A
N/A	Landing Curb? (Y/N)	N/A	N/A	DWS Offset (in)	N/A
N/A	Shared Landing?	N/A			
N/A	Gutter Ponding?	N/A	N/A	Gutter Slope (%)	N/A
N/A	Gutter Lip Ht (in)	N/A	N/A	Gutter X Slope (%)	N/A
N/A	Painted X Walk1?	No	N/A	Painted X Walk2?	N/A
	X Walk 1 Direction	To NE		X Walk 2 Direction	N/A
N/A	X Walk 1 Width (in)	N/A	N/A	X Walk 2 Width (in)	N/A
	X Walk 1 Slope (%)	4.7		X Walk 2 Slope (%)	N/A
	X Walk 1 X Slope (%)	8.5		X Walk 2 X Slope (%)	N/A

Possible Solutions:

Remove & Replace Entire Ramp.

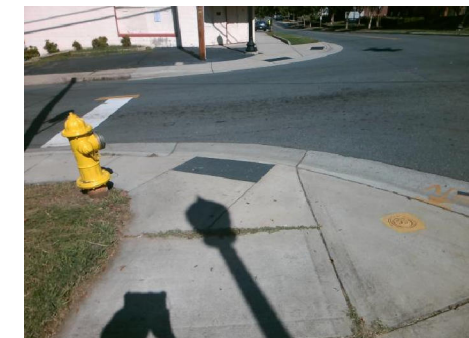
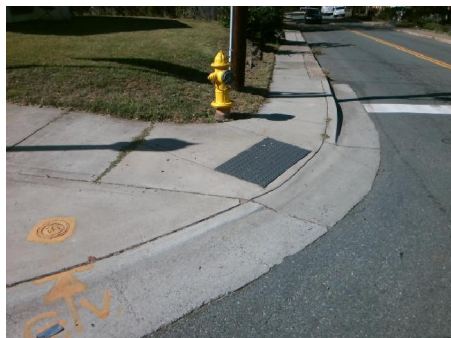
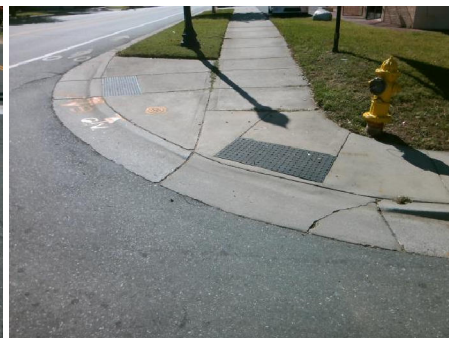
Street 1 Name **BELMONT AV**
 Stop Condition-Street 2 **StopSign**
 Street 2 Name **N/A**
 Stop Condition-Street 1 **N/A**
