Access Compliance Report

Public Rights-of-Way

(Curb Ramps)

Intersection ID: 28868	Main Street: BIRDWELL_CT	Cross Street: SUTTONVIEW_DR	Location: W
ADA ID: B26975E10B0D	Ramp Type: PerpDiag	Initial Pass/Fail: Fail	Overall Compliance: No
Severity Score: 1.25			
Codes/Mitigation Info/Possible Solution		Field Measurements/Component Compliance

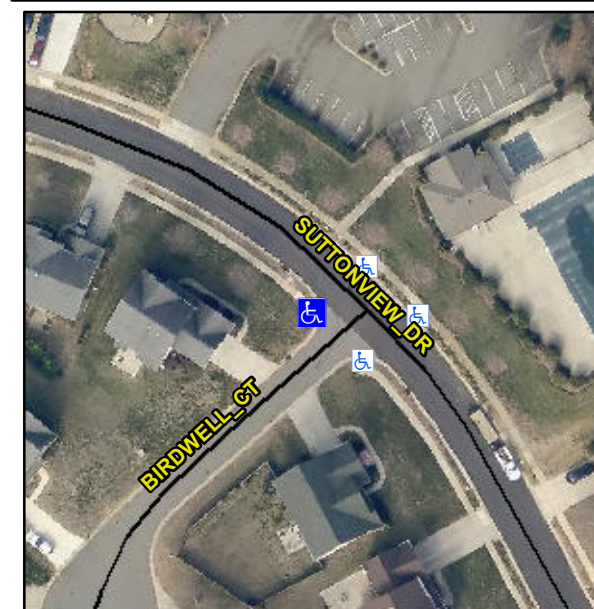
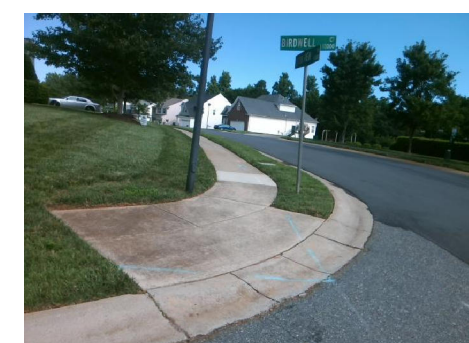
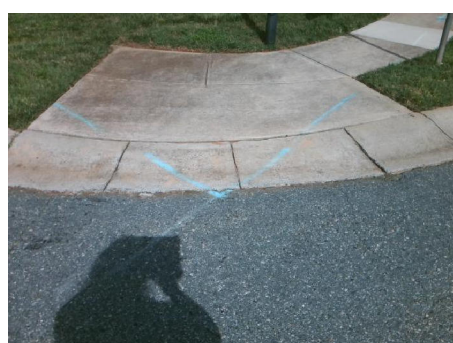
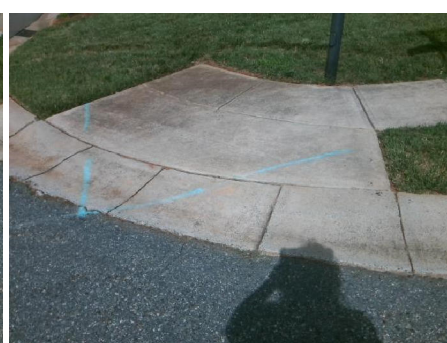
Not Found, R304.5.3

Compliance	Description	Data	Compliance	Description	Data
N/A	Ramp Length (in)	36.0	Yes	Ramp Slope (%)	5.0
Yes	Ramp Width (in)	54.0	No	Ramp XSlope (%)	4.6
N/A	Flare Type LT	N/A	N/A	Flare Type RT	N/A
N/A	Flare Slope LT (%)	N/A	N/A	Flare Slope RT (%)	N/A
N/A	Flare Traversable LT?	N/A	N/A	Flare Traversable RT?	N/A
N/A	Landing Length (in)	N/A	N/A	DWS Provided?	N/A
N/A	Landing Width (in)	N/A	N/A	DWS Contrast?	N/A
N/A	Landing Slope (%)	N/A	N/A	DWS Length (in)	N/A
N/A	Landing X Slope (%)	N/A	N/A	DWS Full Width?	N/A
N/A	Landing Curb? (Y/N)	N/A	N/A	DWS Offset (in)	N/A
N/A	Shared Landing?	N/A			
N/A	Gutter Ponding?	N/A	N/A	Gutter Slope (%)	N/A
N/A	Gutter Lip Ht (in)	N/A	N/A	Gutter X Slope (%)	N/A
N/A	Painted X Walk1?	No	N/A	Painted X Walk2?	No
	X Walk 1 Direction	To SE		X Walk 2 Direction	To NE
N/A	X Walk 1 Width (in)	N/A	N/A	X Walk 2 Width (in)	N/A
	X Walk 1 Slope (%)	4.2		X Walk 2 Slope (%)	0.2
	X Walk 1 X Slope (%)	1.7		X Walk 2 X Slope (%)	3.9

N/A	Ramp inside XWalk1?	N/A	N/A	Ramp inside XWalk2?	N/A
	Road Slope (%)	2.5	N/A	Clear Space?	N/A
	Road X Slope (%)	2.6	N/A	Clear Space to XWalk (in)	N/A
N/A	Any Obstructions?	N/A	N/A	Storm Grate/Utility Hazard?	N/A
	Obstruction Type			Storm Grate/Utility Type	
		N/A			N/A
		Yes		Surface Condition? (G/P)	Good

Remove & Replace Curb Ramp With Two New Directional Ramps or Equivalent.
