Access Compliance Report

Public Rights-of-Way

(Curb Ramps)

Intersection ID: N/A	Main Street: GLENBURN_LN	Cross Street: LOCHY_LN	Location: NW
ADA ID: B273FA5657B8	Ramp Type: PerpDiag	Initial Pass/Fail: Fail	Overall Compliance: No
Severity Score: 21.25			
Codes/Mitigation Info/Possible Solution		Field Measurements/Component Compliance

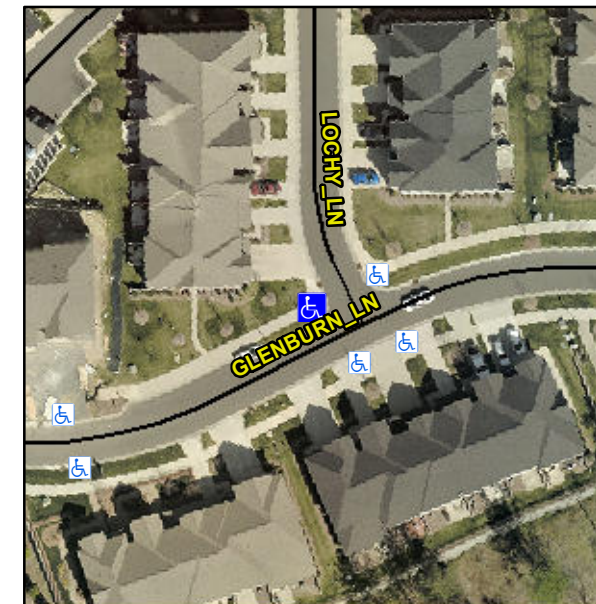
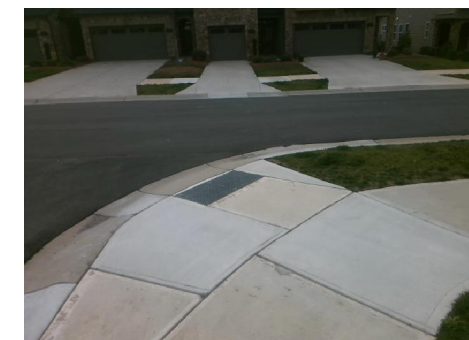
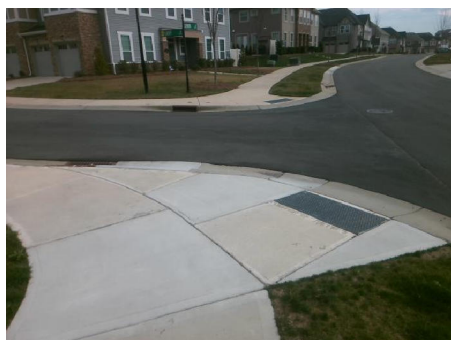
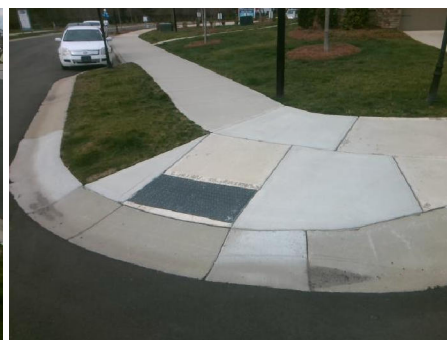
Not Found, R304.5.1, R304.2.2

Compliance	Description	Data	Compliance	Description	Data
N/A	Ramp Length (in)	76.0	No	Ramp Slope (%)	8.5
No	Ramp Width (in)	46.5	Yes	Ramp XSlope (%)	0.5
N/A	Flare Type LT	N/A	N/A	Flare Type RT	N/A
N/A	Flare Slope LT (%)	N/A	N/A	Flare Slope RT (%)	N/A
N/A	Flare Traversable LT?	N/A	N/A	Flare Traversable RT?	N/A
N/A	Landing Length (in)	N/A	N/A	DWS Provided?	N/A
N/A	Landing Width (in)	N/A	N/A	DWS Contrast?	N/A
N/A	Landing Slope (%)	N/A	N/A	DWS Length (in)	N/A
N/A	Landing X Slope (%)	N/A	N/A	DWS Full Width?	N/A
N/A	Landing Curb? (Y/N)	N/A	N/A	DWS Offset (in)	N/A
N/A	Shared Landing?	N/A			
N/A	Gutter Ponding?	N/A	N/A	Gutter Slope (%)	N/A
N/A	Gutter Lip Ht (in)	N/A	N/A	Gutter X Slope (%)	N/A
N/A	Painted X Walk1?	No	N/A	Painted X Walk2?	No
	X Walk 1 Direction	To SE		X Walk 2 Direction	To NE
N/A	X Walk 1 Width (in)	N/A	N/A	X Walk 2 Width (in)	N/A
	X Walk 1 Slope (%)	2.1		X Walk 2 Slope (%)	3.1
	X Walk 1 X Slope (%)	2.6		X Walk 2 X Slope (%)	0.1

N/A	Ramp inside XWalk1?	N/A	N/A	Ramp inside XWalk2?	N/A
	Road Slope (%)	1.9	N/A	Clear Space?	N/A
	Road X Slope (%)	3.5	N/A	Clear Space to XWalk (in)	N/A
N/A	Any Obstructions?	N/A	N/A	Storm Grate/Utility Hazard?	N/A
	Obstruction Type			Storm Grate/Utility Type	
		N/A			N/A
			Yes	Surface Condition? (G/P)	Good

Remove & Replace Curb Ramp With Two New Directional Ramps or Equivalent.
