# Access Compliance Report

## Public Rights-of-Way

| Intersection ID: 15001 | Main Street: N_DOTGER_AV | Cross Street: VAIL_AV | Location: | N |
| ADA ID: B274FCFE8A4D | Ramp Type: BlendTrans1 | Initial Pass/Fail: Fail | Overall Compliance: No | Severity Score: 25 |

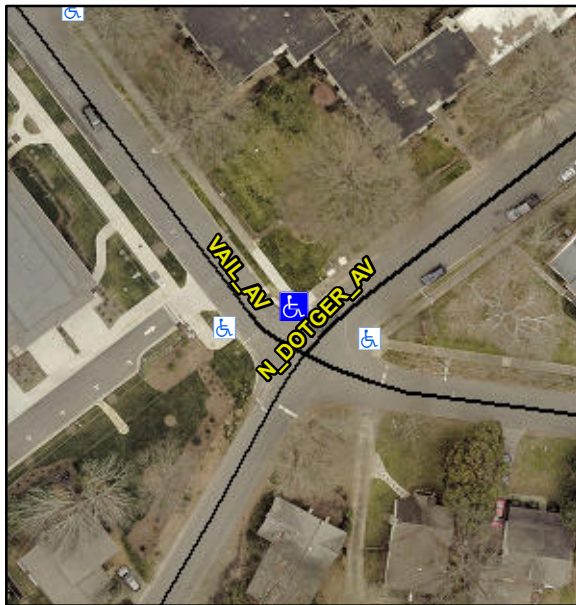
**Not Found, R304.5.3**

| Compliance | Description | Data | Compliance | Description | Data |
|---|---|---|---|---|---|
| Yes | Ramp Width (in) | 48.0 | No | BlendTrans XSlope (%) | 9.1 |
| | | | No | Curb Slope (%) | 17.4 |

**Remove & Replace Curb Ramp With Two New Directional Ramps or Equivalent.**
