Access Compliance Report

Public Rights-of-Way

(Curb Ramps)

| Intersection ID: 31765 | Main Street: FIRST_RUN_CT | Cross Street: PINYON_PINE_LN | Location: E |

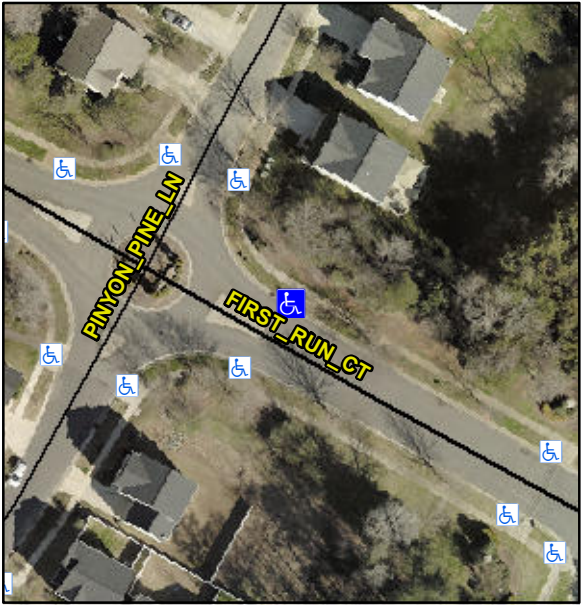
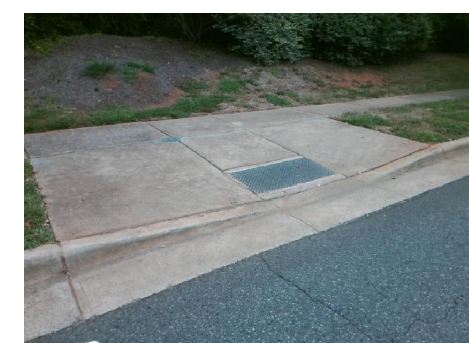
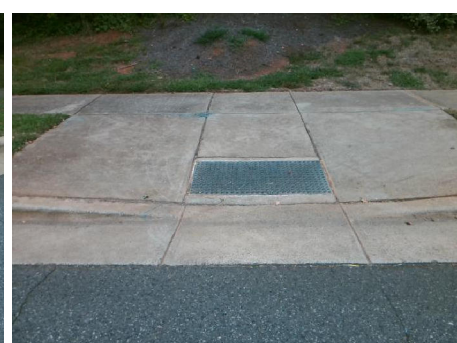
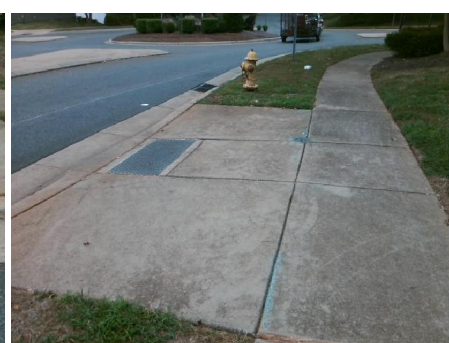
| ADA ID: B2766EB72B40 | Ramp Type: Perp | Initial Pass/Fail: Fail | Overall Compliance: No |

| Codes/Mitigation Info/Possible Solution | | | Field Measurements/Component Compliance | | |
|--|--|--|---|---|---|
| | Remove & Replace Entire Ramp. | | No | Ramp Length (in) | 86.0 |
| <p>Surveyor Notes:</p> <p>N/A</p> <p>PROW/ADA:</p> <p>R304.2.2, R304.5.3</p> | | | N/A | Flare Type RT | N/A |

| Codes/Mitigation Info/Possible Solution | | | Field Measurements/Component Compliance | | |
|--|--|--|---|---|---|
| | Possible Solutions: | | Compliance | Description | Data |
