## Access Compliance Report Public Rights-of-Way (Curb Ramps)

Intersection ID: 50705 Main Street: HARMONIOUS\_ST Cross Street: GENERATIONS\_ST Location: NE

ADA ID: B285A0124DC1 Ramp Type: PerpDiag Initial Pass/Fail: Fail Overall Compliance: No Severity Score: 12.5

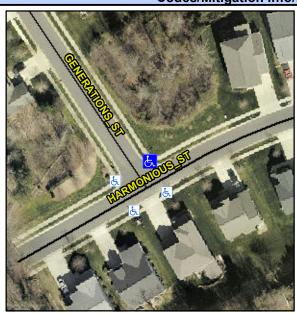
Field Measurements/Component Compliance						
Compliance Description		Data	Comp	liance	Description	Data
N/A	Ramp Length (in)	47.0	No	Ramp	Slope (%)	8.7
Yes	Ramp Width (in)	48.0	Yes	Ramp	XSlope (%)	1.4
N/A	Flare Type LT	N/A	N/A	Flare	Type RT	N/A
N/A	Flare Slope LT (%)	N/A	N/A	Flare	Slope RT (%)	N/A
N/A	Flare Traversable LT?	N/A	N/A	Flare	Traversable RT?	N/A
N/A	Landing Length (in)	N/A	N/A	DWS	Provided?	N/A
N/A	Landing Width (in)	N/A	N/A	DWS	Contrast?	N/A
N/A	Landing Slope (%)	N/A	N/A	DWS	Length (in)	N/A
N/A	Landing X Slope (%)	N/A	N/A	DWS	Full Width?	N/A
N/A	Landing Curb? (Y/N)	N/A	N/A	DWS	Offset (in)	N/A
N/A	Shared Landing?	N/A				
N/A	Gutter Ponding?	N/A	N/A	Gutte	Slope (%)	N/A
N/A	Gutter Lip Ht (in)	N/A	N/A	Gutte	X Slope (%)	N/A
N/A	Painted X Walk1?	No	N/A	Painte	ed X Walk2?	No
	X Walk 1 Direction	To SW		X Wal	k 2 Direction	To SE
N/A	X Walk 1 Width (in)	N/A	N/A	X Wal	k 2 Width (in)	N/A
	X Walk 1 Slope (%)	2.6		X Wal	k 2 Slope (%)	5.8

X Walk 1 X Slope (%)	6.0		X Wal	k 2 X Slope (%)	2.8
N/A	Ramp inside XWalk1?	N/A	N/A	Ramp	inside XWalk2?	N/A
	Road Slope (%)	3.5	N/A	Clear	Space?	N/A
	Road X Slope (%)	5.2	N/A	Clear	Space to XWalk (in)	N/A
N/A	Any Obstructions?	N/A	N/A	Storm	Grate/Utility Hazard?	N/A
	Obstruction Type			Storm	Grate/Utility Type	
		N/A				N/A
			Yes	Surfac	ce Condition? (G/P)	Good
MAN STATE

Remove & Replace Curb Ramp With Two New Directional Ramps or Equivalent.

R304.2.2

Total Cost: \$ 3200.00
