## Access Compliance Report Public Rights-of-Way (Curb Ramps)

Intersection ID: 16545 Main Street: N\_SHARON\_AMITY\_RD Cross Street: MONROE\_RD Location: SE

ADA ID: B28B92DC84C0 Ramp Type: PerpDiag Initial Pass/Fail: Fail Overall Compliance: No Severity Score: 47.5

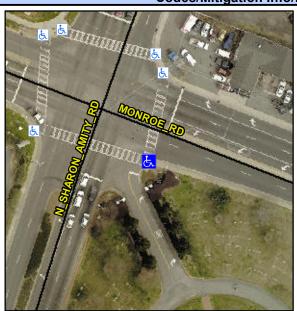
Compliance Description Data Compliance Description Data Yes N/A Ramp Length (in) 60.0 Ramp Slope (%) 5.1 No Ramp XSlope (%) No Ramp Width (in) 25.0 5.6 N/A N/A Flare Type LT N/A Flare Type RT N/A N/A N/A N/A Flare Slope RT (%) N/A Flare Slope LT (%) N/A Flare Traversable LT? N/A N/A Flare Traversable RT? N/A N/A N/A N/A DWS Provided? N/A Landing Length (in) N/A Landing Width (in) N/A N/A **DWS Contrast?** N/A N/A N/A N/A Landing Slope (%) DWS Length (in) N/A N/A Landing X Slope (%) N/A N/A DWS Full Width? N/A N/A Landing Curb? (Y/N) N/A N/A DWS Offset (in) N/A N/A N/A Shared Landing? N/A **Gutter Ponding?** N/A N/A Gutter Slope (%) N/A N/A Gutter Lip Ht (in) 0.5 N/A Gutter X Slope (%) N/A N/A Painted X Walk1? Yes N/A Painted X Walk2? Yes X Walk 1 Direction To NE X Walk 2 Direction To NW N/A 105.0 112.0 X Walk 1 Width (in) X Walk 2 Width (in) X Walk 1 Slope (%) 3.8 X Walk 2 Slope (%) 1.0 X Walk 1 X Slope (%) 0.2 X Walk 2 X Slope (%) 3.0 N/A N/A Ramp inside XWalk2? Ramp inside XWalk1? Yes Yes Road Slope (%) 2.1 N/A Clear Space? N/A N/A Road X Slope (%) 3.0 Clear Space to XWalk (in) N/A N/A N/A N/A Any Obstructions? Storm Grate/Utility Hazard? N/A **Obstruction Type** Storm Grate/Utility Type N/A N/A

Remove & Replace Curb Ramp With
Two New Directional Ramps or
Equivalent.

PROW/ADA:
R304.5.1, R304.5.3
