Intersection ID: 7228	Main Street: CARRINGTON_DR	Cross Street: TILDEN_RD	Location:	N
ADA ID: B2947D1774E2	Ramp Type: Perp	Initial Pass/Fail: Fail	Overall Compliance: No	Severity Score: 22.5

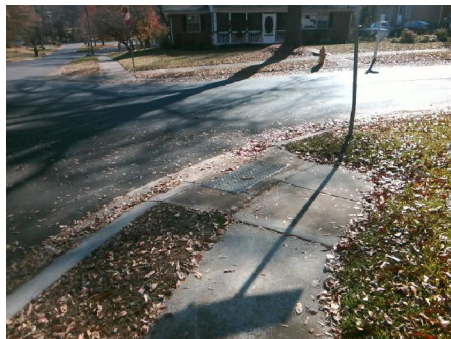
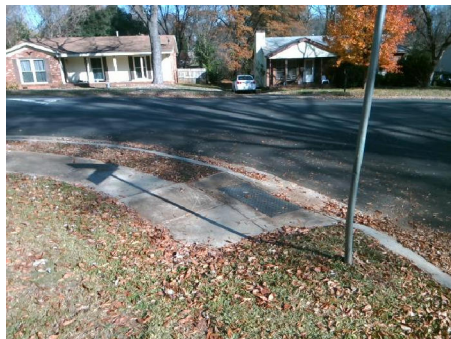
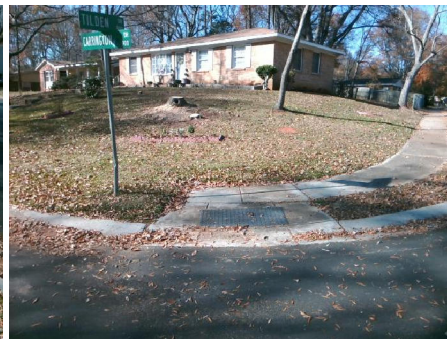
Compliance	Description	Data	Compliance	Description	Data
N/A	Ramp Length (in)	37.0	No	Ramp Slope (%)	10.6
No	Ramp Width (in)	45.5	No	Ramp XSlope (%)	4.4
N/A	Flare Type LT	N/A	N/A	Flare Type RT	N/A
N/A	Flare Slope LT (%)	N/A	N/A	Flare Slope RT (%)	N/A
N/A	Flare Traversable LT?	N/A	N/A	Flare Traversable RT?	N/A
N/A	Landing Length (in)	N/A	N/A	DWS Provided?	N/A
N/A	Landing Width (in)	N/A	N/A	DWS Contrast?	N/A
N/A	Landing Slope (%)	N/A	N/A	DWS Length (in)	N/A
N/A	Landing X Slope (%)	N/A	N/A	DWS Full Width?	N/A
N/A	Landing Curb? (Y/N)	N/A	N/A	DWS Offset (in)	N/A
N/A	Shared Landing?	N/A			
N/A	Gutter Ponding?	N/A	N/A	Gutter Slope (%)	N/A
N/A	Gutter Lip Ht (in)	N/A	N/A	Gutter X Slope (%)	N/A
N/A	Painted X Walk1?	No	N/A	Painted X Walk2?	N/A
	X Walk 1 Direction	To S		X Walk 2 Direction	N/A
N/A	X Walk 1 Width (in)	N/A	N/A	X Walk 2 Width (in)	N/A
	X Walk 1 Slope (%)	1.5		X Walk 2 Slope (%)	N/A
	X Walk 1 X Slope (%)	3.4		X Walk 2 X Slope (%)	N/A

N/A	Ramp inside XWalk1?	N/A	N/A	Ramp inside XWalk2?	N/A
	Road Slope (%)	N/A	N/A	Clear Space?	N/A
	Road X Slope (%)	N/A	N/A	Clear Space to XWalk (in)	N/A
N/A	Any Obstructions?	N/A	N/A	Storm Grate/Utility Hazard?	N/A
	Obstruction Type			Storm Grate/Utility Type	
		N/A			N/A
			Yes	Surface Condition? (G/P)	Good

### Remove & Replace Entire Ramp.
