Access Compliance Report

Public Rights-of-Way

(Curb Ramps)

Intersection ID: 3874	Main Street: GARRISON_RD	Cross Street: MARBLE_HILL_DR	Location:	N
ADA ID: B296EA0C1B1B	Ramp Type: PerpDiag	Initial Pass/Fail: Fail	Overall Compliance: No	Severity Score: 30
Codes/Mitigation Info/Possible Solution		Field Measurements/Component Compliance

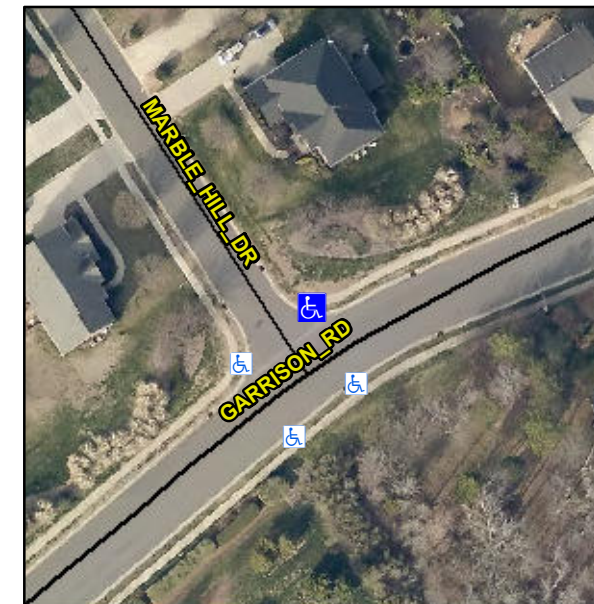
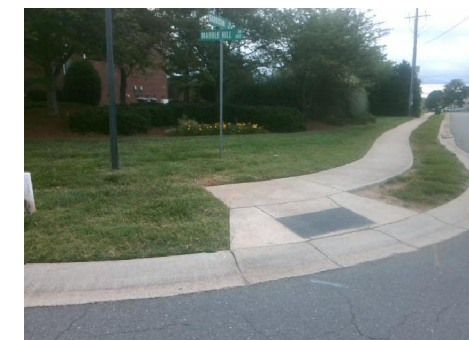
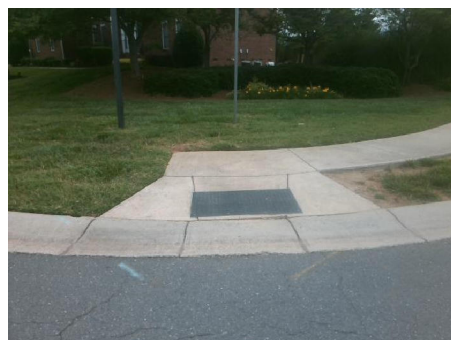
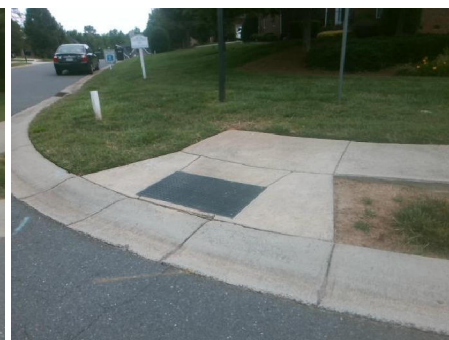
Not Found, R304.5.1, R304.2.2

Compliance	Description	Data	Compliance	Description	Data
N/A	Ramp Length (in)	45.0	No	Ramp Slope (%)	9.4
No	Ramp Width (in)	35.5	Yes	Ramp XSlope (%)	0.9
N/A	Flare Type LT	N/A	N/A	Flare Type RT	N/A
N/A	Flare Slope LT (%)	N/A	N/A	Flare Slope RT (%)	N/A
N/A	Flare Traversable LT?	N/A	N/A	Flare Traversable RT?	N/A
N/A	Landing Length (in)	N/A	N/A	DWS Provided?	N/A
N/A	Landing Width (in)	N/A	N/A	DWS Contrast?	N/A
N/A	Landing Slope (%)	N/A	N/A	DWS Length (in)	N/A
N/A	Landing X Slope (%)	N/A	N/A	DWS Full Width?	N/A
N/A	Landing Curb? (Y/N)	N/A	N/A	DWS Offset (in)	N/A
N/A	Shared Landing?	N/A			
N/A	Gutter Ponding?	N/A	N/A	Gutter Slope (%)	N/A
N/A	Gutter Lip Ht (in)	N/A	N/A	Gutter X Slope (%)	N/A
N/A	Painted X Walk1?	No	N/A	Painted X Walk2?	No
	X Walk 1 Direction	To SE		X Walk 2 Direction	To SW
N/A	X Walk 1 Width (in)	N/A	N/A	X Walk 2 Width (in)	N/A
	X Walk 1 Slope (%)	2.8		X Walk 2 Slope (%)	1.1
	X Walk 1 X Slope (%)	0.3		X Walk 2 X Slope (%)	0.8

N/A	Ramp inside XWalk1?	N/A	N/A	Ramp inside XWalk2?	N/A
	Road Slope (%)	0.3	N/A	Clear Space?	N/A
	Road X Slope (%)	1.4	N/A	Clear Space to XWalk (in)	N/A
N/A	Any Obstructions?	N/A	N/A	Storm Grate/Utility Hazard?	N/A
	Obstruction Type			Storm Grate/Utility Type	
		N/A			N/A
			Yes	Surface Condition? (G/P)	Good

Remove & Replace Curb Ramp With Two New Directional Ramps or Equivalent.
