Access Compliance Report Public Rights-of-Way (Curb Ramps)

Main Street: BROMWICH_RD **Cross Street: BULLARD ST** Location: Intersection ID: 29454 SE Initial Pass/Fail: Fail **Overall Compliance: No** 22.5 ADA ID: B2B433143B9F Ramp Type: Combination1 **Severity Score:**

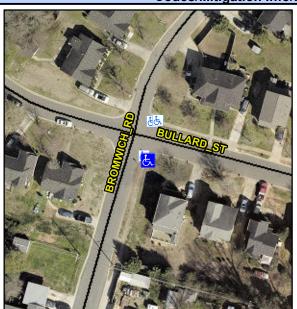
N/A	Landing Length (in)	N/A	N/A	DWS Provided?	N/A
N/A	Landing Width (in)	N/A	N/A	DWS Contrast?	N/A
N/A	Landing Slope (%)	N/A	N/A	DWS Length (in)	N/A
N/A	Landing X Slope (%)	N/A	N/A	DWS Full Width?	N/A
N/A	Landing Curb? (Y/N)	N/A	N/A	DWS Offset (in)	N/A
N/A	Shared Landing?	N/A			
N/A	Gutter Ponding?	Yes	N/A	Gutter Slope (%)	N/A
N/A	Gutter Lip Ht (in)	N/A	N/A	Gutter X Slope (%)	N/A
N/A	Painted X Walk1?	No	N/A	Painted X Walk2?	N/A
	X Walk 1 Direction	To NE		X Walk 2 Direction	N/A
	X Walk 1 Width (in)	N/A		X Walk 2 Width (in)	N/A
	X Walk 1 Slope (%)	4.5		X Walk 2 Slope (%)	N/A
	X Walk 1 X Slope (%)	2.5		X Walk 2 X Slope (%)	N/A
N/A	Ramp inside XWalk1?	N/A	N/A	Ramp inside XWalk2?	N/A
	Road Slope (%)	N/A		Clear Space?	N/A
	Road X Slope (%)	N/A	N/A	Clear Space to XWalk (in)	N/A
			N/A	Any Obstruction?	N/A
				Obstruction Type	
					N/A
			N/A	Storm Grate/Utility Hazard?	N/A
			l	Storm Grate/Utility Type	
					N/A

Possible Solutions:					
Remove & Replace Entire Ramp.					
Surveyor Notes:					
N/A					
PROW/ADA:					
R304.5.1, R304.5.1, R304.2.2,					
R304.3.2, R304.5.3
