## Access Compliance Report Public Rights-of-Way (Curb Ramps)

Intersection ID: 10033070 Main Street: NORTH\_COMMUNITY\_HOUSE\_RDss Street: N/A Location: SW

ADA ID: B2B9FEB37EF2 Ramp Type: Para Initial Pass/Fail: Fail Overall Compliance: No Severity Score: 26.25

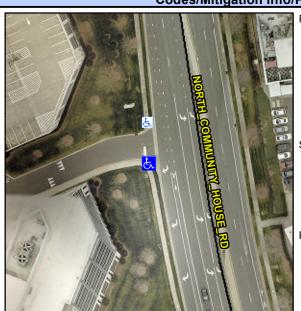
Data	liance Description	Comp	Data	liance Description	Comp
57.5	Ramp Length RT (in)	N/A	58.0	Ramp Length LT (in)	N/A
60.5	Ramp Width RT (in)	Yes	59.0	Ramp Width LT (in)	Yes

14.6	Ramp Slope RT (%)	No	10.7	Ramp Slope LT (%)	No
3.9	Ramp XSlope RT (%)	No	1.4	Ramp XSlope LT (%)	Yes
N/A	DWS Provided?	N/A	N/A	Landing Length (in)	N/A
N/A	DWS Contrast?	N/A	N/A	Landing Width (in)	N/A
N/A	DWS Length (in)	N/A	N/A	Landing Slope (%)	N/A
N/A	DWS Full Width?	N/A	N/A	Landing X Slope (%)	N/A
N/A	DWS Offset (in)	N/A	N/A	Landing Curb? (Y/N)	N/A
			N/A	Shared Landing?	N/A
N/A	Gutter Slope (%)	N/A	N/A	Gutter Ponding?	N/A
N/A	Gutter X Slope (%)	N/A	N/A	Gutter Lip Ht (in)	N/A
N/A	Painted X Walk2?	N/A	No	Painted X Walk1?	N/A
N/A	X Walk 2 Direction		To N	X Walk 1 Direction	
N/A	X Walk 2 Width (in)	N/A	N/A	X Walk 1 Width (in)	N/A
N/A	X Walk 2 Slope (%)		2.4	X Walk 1 Slope (%)	
N/A	X Walk 2 X Slope (%)		5.7	X Walk 1 X Slope (%)	
N/A	Ramp inside XWalk2?	N/A	N/A	Ramp inside XWalk1?	N/A
N/A	Clear Space?	N/A	N/A	Road Slope (%)	
N/A	Clear Space to XWalk (in)	N/A	N/A	Road X Slope (%)	
N/A	Storm Grate/Utility Hazard?	N/A	N/A	Any Obstructions?	N/A

Storm Grate/Utility Type			Obstruction Type	
N/A			N/A		
Good	Surface Condition? (G/P)	Yes			
7.0	Curb Slope (%)	N/A

Remove & Replace Entire Ramp.

R304.3.2, R304.5.3
