Access Compliance Report

Public Rights-of-Way

(Curb Ramps)

Intersection ID: 10996	Main Street: E_24TH_ST	Cross Street: N_DAVIDSON_ST	Location: N
ADA ID: B2D543AA807C	Ramp Type: Perp	Initial Pass/Fail: Fail	Overall Compliance: No
Severity Score: 35			
Codes/Mitigation Info/Possible Solution		Field Measurements/Component Compliance

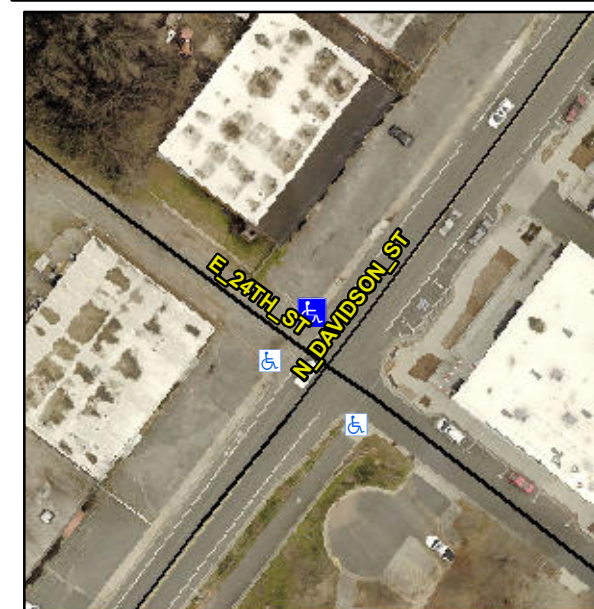
Not Found, R304.5.1, R304.2.2

Compliance	Description	Data	Compliance	Description	Data
N/A	Ramp Length (in)	41.0	No	Ramp Slope (%)	12.2
No	Ramp Width (in)	41.5	Yes	Ramp XSlope (%)	3.3
N/A	Flare Type LT	N/A	N/A	Flare Type RT	N/A
N/A	Flare Slope LT (%)	N/A	N/A	Flare Slope RT (%)	N/A
N/A	Flare Traversable LT?	N/A	N/A	Flare Traversable RT?	N/A
N/A	Landing Length (in)	N/A	N/A	DWS Provided?	N/A
N/A	Landing Width (in)	N/A	N/A	DWS Contrast?	N/A
N/A	Landing Slope (%)	N/A	N/A	DWS Length (in)	N/A
N/A	Landing X Slope (%)	N/A	N/A	DWS Full Width?	N/A
N/A	Landing Curb? (Y/N)	N/A	N/A	DWS Offset (in)	N/A
N/A	Shared Landing?	N/A			
N/A	Gutter Ponding?	N/A	N/A	Gutter Slope (%)	N/A
N/A	Gutter Lip Ht (in)	N/A	N/A	Gutter X Slope (%)	N/A
N/A	Painted X Walk1?	No	N/A	Painted X Walk2?	N/A
	X Walk 1 Direction	To SW		X Walk 2 Direction	N/A
N/A	X Walk 1 Width (in)	N/A	N/A	X Walk 2 Width (in)	N/A
	X Walk 1 Slope (%)	0.4		X Walk 2 Slope (%)	N/A
	X Walk 1 X Slope (%)	7.8		X Walk 2 X Slope (%)	N/A

N/A	Ramp inside XWalk1?	N/A	N/A	Ramp inside XWalk2?	N/A
	Road Slope (%)	N/A	N/A	Clear Space?	N/A
	Road X Slope (%)	N/A	N/A	Clear Space to XWalk (in)	N/A
N/A	Any Obstructions?	N/A	N/A	Storm Grate/Utility Hazard?	N/A
	Obstruction Type			Storm Grate/Utility Type	
		N/A			N/A
			Yes	Surface Condition? (G/P)	Good

Possible Solutions:

Remove & Replace Entire Ramp.

Total Cost: \$ 1850.00
