# Access Compliance Report

## Public Rights-of-Way

### (Curb Ramps)

Intersection ID: 50594	Main Street: BEAR_GRASS_LN	Cross Street: GRAY_WILLOW_RD	Location: W
ADA ID: B2EC73B528CA	Ramp Type: Perp	Initial Pass/Fail: Fail	Overall Compliance: No
Severity Score: 21.25			
Codes/Mitigation Info/Possible Solution		Field Measurements/Component Compliance

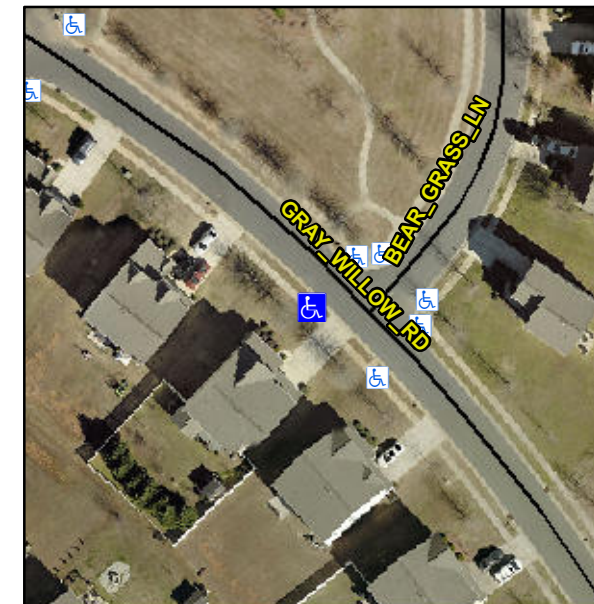
**Not Found, R304.5.1, R304.2.2**

Compliance	Description	Data	Compliance	Description	Data
N/A	Ramp Length (in)	48.5	No	Ramp Slope (%)	8.6
No	Ramp Width (in)	47.5	Yes	Ramp XSlope (%)	1.7
N/A	Flare Type LT	N/A	N/A	Flare Type RT	N/A
N/A	Flare Slope LT (%)	N/A	N/A	Flare Slope RT (%)	N/A
N/A	Flare Traversable LT?	N/A	N/A	Flare Traversable RT?	N/A
N/A	Landing Length (in)	N/A	N/A	DWS Provided?	N/A
N/A	Landing Width (in)	N/A	N/A	DWS Contrast?	N/A
N/A	Landing Slope (%)	N/A	N/A	DWS Length (in)	N/A
N/A	Landing X Slope (%)	N/A	N/A	DWS Full Width?	N/A
N/A	Landing Curb? (Y/N)	N/A	N/A	DWS Offset (in)	N/A
N/A	Shared Landing?	N/A			
N/A	Gutter Ponding?	N/A	N/A	Gutter Slope (%)	N/A
N/A	Gutter Lip Ht (in)	N/A	N/A	Gutter X Slope (%)	N/A
N/A	Painted X Walk1?	No	N/A	Painted X Walk2?	N/A
	X Walk 1 Direction	To NE		X Walk 2 Direction	N/A
N/A	X Walk 1 Width (in)	N/A	N/A	X Walk 2 Width (in)	N/A
	X Walk 1 Slope (%)	2.0		X Walk 2 Slope (%)	N/A
	X Walk 1 X Slope (%)	1.5		X Walk 2 X Slope (%)	N/A

**Remove & Replace Entire Ramp.**

Total Cost: \$ 1850.00

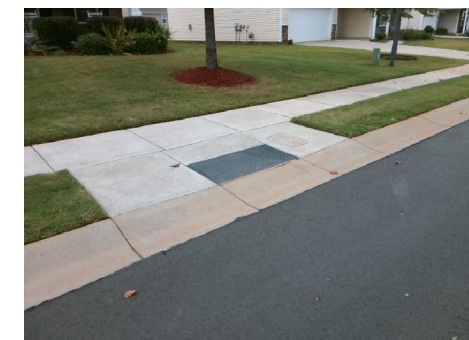
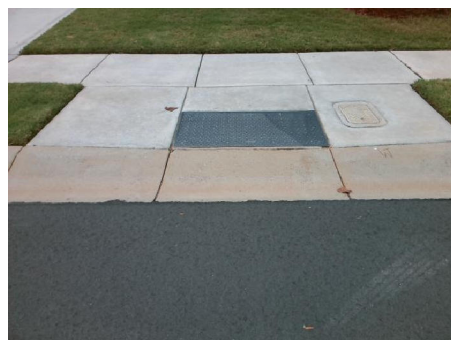
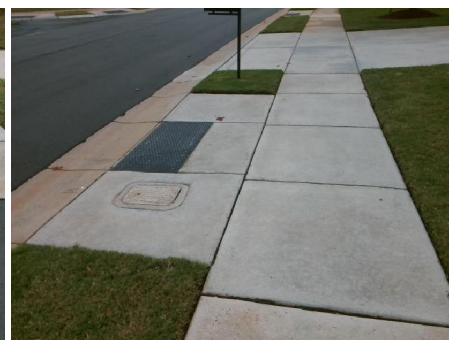
N/A	Ramp inside XWalk1?	N/A	N/A	Ramp inside XWalk2?	N/A
	Road Slope (%)	N/A	N/A	Clear Space?	N/A
	Road X Slope (%)	N/A	N/A	Clear Space to XWalk (in)	N/A
N/A	Any Obstructions?	N/A	N/A	Storm Grate/Utility Hazard?	N/A
	Obstruction Type			Storm Grate/Utility Type	
		N/A			N/A
			Yes	Surface Condition? (G/P)	Good
