Access Compliance Report Public Rights-of-Way (Curb Ramps)

Intersection ID: 10224 Main Street: HERRIN_AV Cross Street: SPENCER_ST Location: NE

ADA ID: B2EDDED2A4C1 Ramp Type: Combination2 Initial Pass/Fail: Fail Overall Compliance: No Severity Score: 13.75

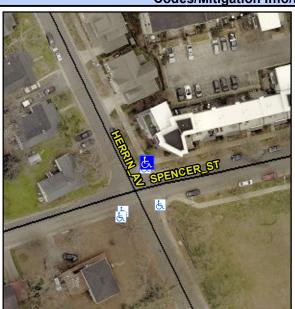
Possible Solutions:						
Remove & Replace Entire Ramp.						
·						
Surveyor Notes:						
N/A						
PROW/ADA:						
Not Found, R304.5.3, R304.3.2
