Access Compliance Report

Public Rights-of-Way

(Curb Ramps)

Intersection ID: 8751	Main Street: CENTRE_ST	Cross Street: ODUM_AV	Location: NW
ADA ID: B2FA00BE2DC8	Ramp Type: Perp	Initial Pass/Fail: Fail	Overall Compliance: No
Severity Score: 21.25			
Codes/Mitigation Info/Possible Solution		Field Measurements/Component Compliance

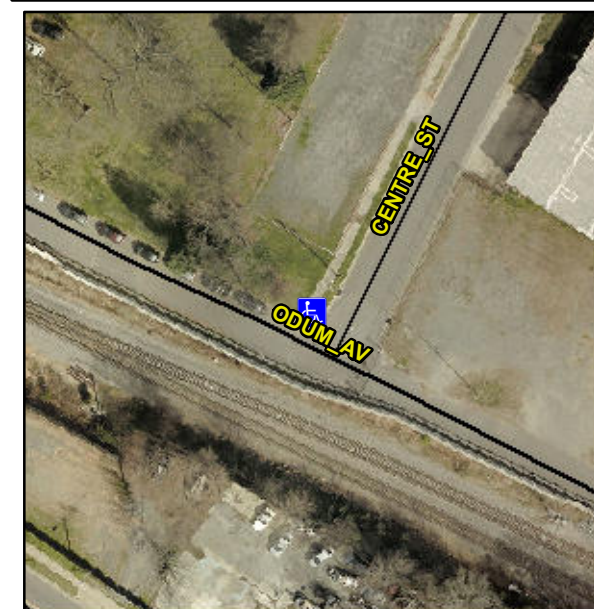
Not Found, R304.5.1, R304.5.3

Compliance	Description	Data	Compliance	Description	Data
N/A	Ramp Length (in)	49.0	Yes	Ramp Slope (%)	7.6
No	Ramp Width (in)	47.5	No	Ramp XSlope (%)	5.3
N/A	Flare Type LT	N/A	N/A	Flare Type RT	N/A
N/A	Flare Slope LT (%)	N/A	N/A	Flare Slope RT (%)	N/A
N/A	Flare Traversable LT?	N/A	N/A	Flare Traversable RT?	N/A
N/A	Landing Length (in)	N/A	N/A	DWS Provided?	N/A
N/A	Landing Width (in)	N/A	N/A	DWS Contrast?	N/A
N/A	Landing Slope (%)	N/A	N/A	DWS Length (in)	N/A
N/A	Landing X Slope (%)	N/A	N/A	DWS Full Width?	N/A
N/A	Landing Curb? (Y/N)	N/A	N/A	DWS Offset (in)	N/A
N/A	Shared Landing?	N/A			
N/A	Gutter Ponding?	N/A	N/A	Gutter Slope (%)	N/A
N/A	Gutter Lip Ht (in)	N/A	N/A	Gutter X Slope (%)	N/A
N/A	Painted X Walk1?	No	N/A	Painted X Walk2?	N/A
	X Walk 1 Direction	To S		X Walk 2 Direction	N/A
N/A	X Walk 1 Width (in)	N/A	N/A	X Walk 2 Width (in)	N/A
	X Walk 1 Slope (%)	1.6		X Walk 2 Slope (%)	N/A
	X Walk 1 X Slope (%)	3.3		X Walk 2 X Slope (%)	N/A

N/A	Ramp inside XWalk1?	N/A	N/A	Ramp inside XWalk2?	N/A
	Road Slope (%)	3.3	N/A	Clear Space?	N/A
	Road X Slope (%)	1.6	N/A	Clear Space to XWalk (in)	N/A
N/A	Any Obstructions?	N/A	N/A	Storm Grate/Utility Hazard?	N/A
	Obstruction Type			Storm Grate/Utility Type	
		N/A			N/A
		Yes		Surface Condition? (G/P)	Good

Possible Solutions:

Remove & Replace Entire Ramp.

Total Cost: \$ 1850.00
