# Access Compliance Report

## Public Rights-of-Way

### (Curb Ramps)

| Intersection ID: 53965 | Main Street: MAGNOLIA_LILY_AV | Cross Street: SPRING_SPRUCE_LN | Location: NW |

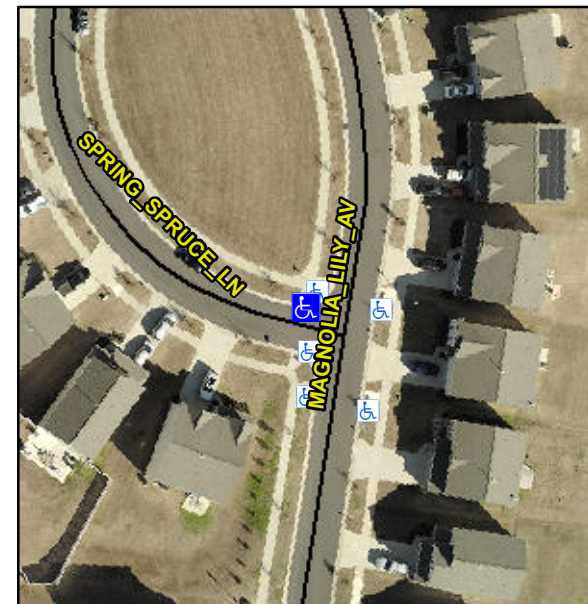
| ADA ID: B30F87098223 | Ramp Type: Perp | Initial Pass/Fail: Fail | Overall Compliance: No |
| Severity Score: 10 | | | |

**R304.5.1, R304.5.3**

| Compliance | Description | Data | Compliance | Description | Data |
|---|---|---|---|---|---|
| N/A | Ramp Length (in) | 96.0 | Yes | Ramp Slope (%) | 5.0 |
| No | Ramp Width (in) | 47.5 | No | Ramp XSlope (%) | 2.4 |

**Remove & Replace Entire Ramp.**

Total Cost: \$ **1850.00**

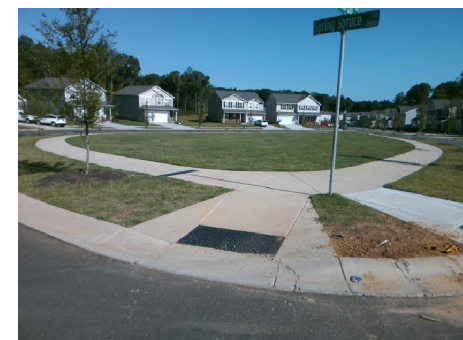
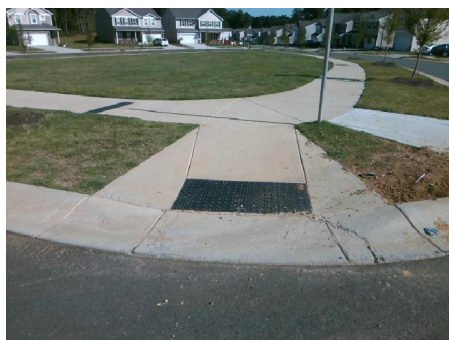
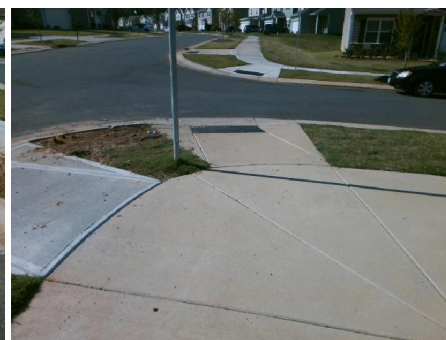
| Compliance | Description | Data | Compliance | Description | Data |
|---|---|---|---|---|---|
| | | | Yes | Surface Condition? (G/P) | Good |
