# Access Compliance Report

## Public Rights-of-Way

### (Curb Ramps)

Intersection ID: 11124	Main Street: N_CLARKSON_ST	Cross Street: CATES_ST	Location: W
ADA ID: B329BA299CB8	Ramp Type: PerpDiag	Initial Pass/Fail: Fail	Overall Compliance: No
Severity Score: 12.5			
Codes/Mitigation Info/Possible Solution		Field Measurements/Component Compliance

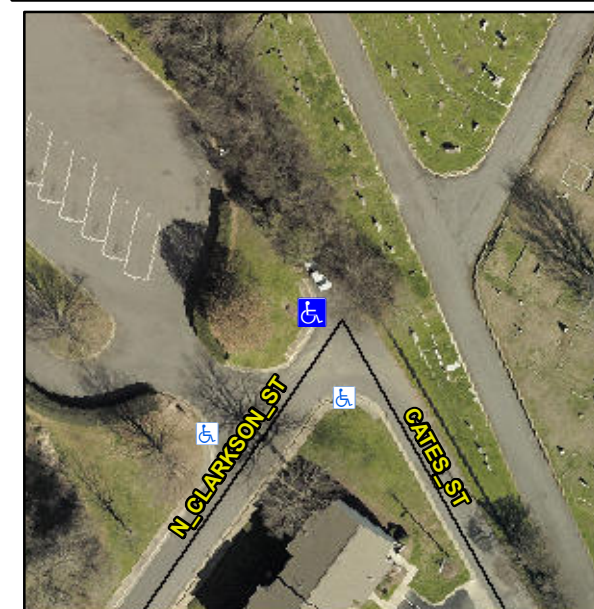
**Not Found, R304.2.2**

Compliance	Description	Data	Compliance	Description	Data
N/A	Ramp Length (in)	51.0	No	Ramp Slope (%)	9.2
Yes	Ramp Width (in)	64.0	Yes	Ramp XSlope (%)	1.1
N/A	Flare Type LT	N/A	N/A	Flare Type RT	N/A
N/A	Flare Slope LT (%)	N/A	N/A	Flare Slope RT (%)	N/A
N/A	Flare Traversable LT?	N/A	N/A	Flare Traversable RT?	N/A
N/A	Landing Length (in)	N/A	N/A	DWS Provided?	N/A
N/A	Landing Width (in)	N/A	N/A	DWS Contrast?	N/A
N/A	Landing Slope (%)	N/A	N/A	DWS Length (in)	N/A
N/A	Landing X Slope (%)	N/A	N/A	DWS Full Width?	N/A
N/A	Landing Curb? (Y/N)	N/A	N/A	DWS Offset (in)	N/A
N/A	Shared Landing?	N/A			
N/A	Gutter Ponding?	N/A	N/A	Gutter Slope (%)	N/A
N/A	Gutter Lip Ht (in)	N/A	N/A	Gutter X Slope (%)	N/A
N/A	Painted X Walk1?	No	N/A	Painted X Walk2?	No
	X Walk 1 Direction	To S		X Walk 2 Direction	To E
N/A	X Walk 1 Width (in)	N/A	N/A	X Walk 2 Width (in)	N/A
	X Walk 1 Slope (%)	6.4		X Walk 2 Slope (%)	0.8
	X Walk 1 X Slope (%)	2.2		X Walk 2 X Slope (%)	6.1

N/A	Ramp inside XWalk1?	N/A	N/A	Ramp inside XWalk2?	N/A
	Road Slope (%)	3.7	N/A	Clear Space?	N/A
	Road X Slope (%)	4.7	N/A	Clear Space to XWalk (in)	N/A
N/A	Any Obstructions?	N/A	N/A	Storm Grate/Utility Hazard?	N/A
	Obstruction Type			Storm Grate/Utility Type	
		N/A			N/A
		Yes		Surface Condition? (G/P)	Good

**Remove & Replace Curb Ramp With Two New Directional Ramps or Equivalent.**
