Access Compliance Report

Public Rights-of-Way

(Curb Ramps)

| Intersection ID: 17113 | Main Street: STERLING_RD | Cross Street: WESTFIELD_RD | Location: NE |

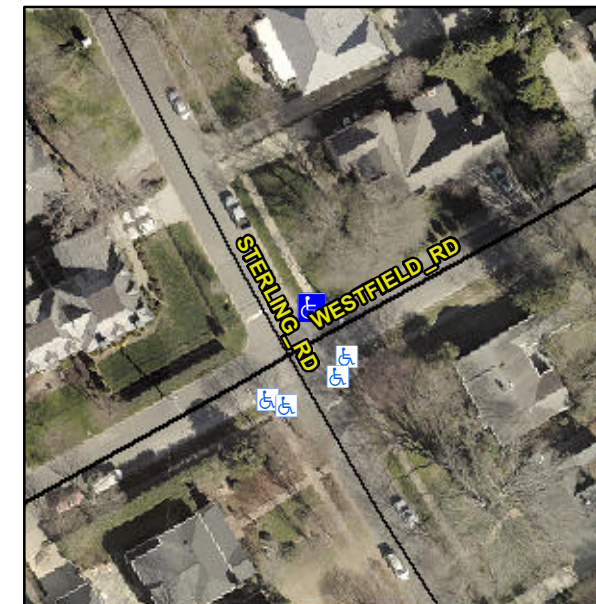
| ADA ID: B32C6E0733B6 | Ramp Type: PerpDiag | Initial Pass/Fail: Fail | Overall Compliance: No |
| Severity Score: 1.25 | | | |

Not Found, R304.5.3

| Compliance | Description | Data | Compliance | Description | Data |
|---|---|---|---|---|---|
| N/A | Ramp Length (in) | 102.0 | Yes | Ramp Slope (%) | 5.9 |
| Yes | Ramp Width (in) | 49.0 | No | Ramp XSlope (%) | 4.6 |

Remove & Replace Curb Ramp With Two New Directional Ramps or Equivalent.

Total Cost: \$ 3200.00
