## **Access Compliance Report Public Rights-of-Way** (Curb Ramps)

Main Street: N CHURCH ST Intersection ID: 9919 Cross Street: W 28TH ST Location: W Initial Pass/Fail: Fail **Overall Compliance: No Severity Score:** ADA ID: B342A66CFF4E Ramp Type: Combination1 72.5

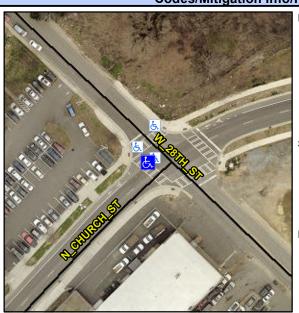
Street 1 Name StopSign N CHURCH ST Stop Condition-Street 1 Street 2 Name N/A Stop Condition-Street 2 N/A Possible Solutions: Compliance Description N/A Remove & Replace Entire Ramp. Yes Yes No N/A No Surveyor Notes: N/A **GTR LIP 1.5** N/A N/A N/A N/A PROW/ADA: N/A Not Found, R304.5.1, R304.2.2, N/A R304.5.3, R304.3.2 N/A N/A N/A N/A N/A
