Access Compliance Report Public Rights-of-Way (Curb Ramps)

Intersection ID: 19251	ID: 19251 Main Street: CHERRY_TRIPP_DR			Street:	VILLAGE_LAKE_DR	Location:	SE		
ADA ID: B34F4580C5F5	Ramp Type: PerpDiag			itial Pass/Fail: Fail Overall Compliance: No				o Severity Score:	50
Codes/Mitigation Info/Possible Solution				Field Measurements/Component Compliance					
	ANE DE	Possible Solutions:		Compliance Description			ata Compliance Description		Data
		Remove & Replace Curb Ramp W	/ith	N/A	Ramp Length (in)	57.0	No	Ramp Slope (%)	12.2
		Two New Directional Ramps or		Yes	Ramp Width (in)	48.0	No	Ramp XSlope (%)	8.4
		Equivalent.		N/A	Flare Type LT	N/A	N/A	Flare Type RT	N/A
				N/A	Flare Slope LT (%)	N/A	N/A	Flare Slope RT (%)	N/A

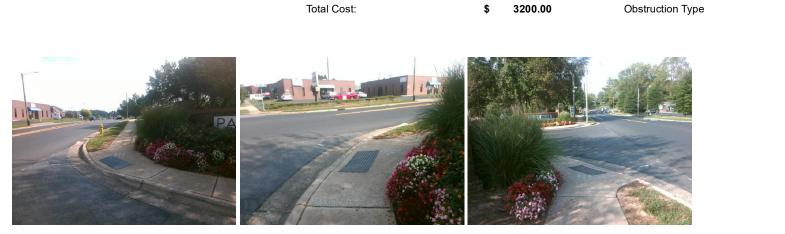
2.51	1 1 2 1	R304.2.2, R304.5.3		N/A	Painted X Walk1?	N/A No	N/A	Painted X Walk2?	N/A No
				IN/A	X Walk 1 Direction	-	N/A	X Walk 2 Direction	To W
A Charles	Part Into					To N			-
		1		N/A	X Walk 1 Width (in)	N/A	N/A	X Walk 2 Width (in)	N/A
Street 1 Name	VILLAGE LAKE DR				X Walk 1 Slope (%)	7.1		X Walk 2 Slope (%)	0.5
Stop Condition-Street 2	None				X Walk 1 X Slope (%)	0.6		X Walk 2 X Slope (%)	7.5
Street 2 Name	CHERRY TRIPP DR			N/A	Ramp inside XWalk1?	N/A	N/A	Ramp inside XWalk2?	N/A
Stop Condition-Street 1	StopSign				Road Slope (%)	3.8	N/A	Clear Space?	N/A
					Road X Slope (%)	8.1	N/A	Clear Space to XWalk (in)	N/A
				N/A	Any Obstructions?	N/A	N/A	Storm Grate/Utility Hazard?	N/A
		Total Cost: \$ 32	200.00		Obstruction Type			Storm Grate/Utility Type	
						N/A			N/A
