## Access Compliance Report Public Rights-of-Way (Curb Ramps)

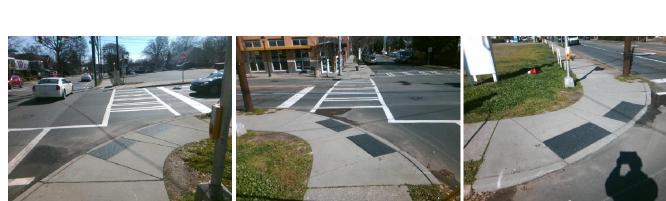
•		·					
Intersection ID: 15211	Main Str	Cross	Street:	SCOTT_AV	Location:	w			
ADA ID: B355F34DEB82	Ramp Ty	Ramp Type: PerpDiag			Initial Pass/Fail: Fail Overall Compliance: No				13.75
Codes/Mitigation Info/Possible Solution				Field Measurements/Component Compliance					
the second se	5 101.1	Possible Solutions:		Compliance Description D			ata Compliance Description		Data
		Remove & Replace Curb Ramp	With	N/A	Ramp Length (in)	64.0	No	Ramp Slope (%)	8.7
		Two New Directional Ramps or		Yes	Ramp Width (in)	105.0	No	Ramp XSlope (%)	2.2
		Equivalent.		N/A	Flare Type LT	N/A	N/A	Flare Type RT	N/A
				N/A	Flare Slope LT (%)	N/A	N/A	Flare Slope RT (%)	N/A

E.	110			N/A	Landing Curb? (Y/N)	N/A	N/A	DWS Offset (in)	N/A
	and the second	4		N/A	Shared Landing?	N/A			
The Holes	1 Parts	PROW/ADA:		N/A	Gutter Ponding?	N/A	N/A	Gutter Slope (%)	N/A
AND	1 7 9	Not Found, R304.2.2, R304.5.3		N/A	Gutter Lip Ht (in)	N/A		Gutter X Slope (%)	N/A
	. 100	Not i bunu, R304.2.2, R304.3.3		N/A	Painted X Walk1?	Yes	N/A	Painted X Walk2?	Yes
and the first of the	19 11 -				X Walk 1 Direction	To SE		X Walk 2 Direction	To NE
				N/A	X Walk 1 Width (in)	106.0	N/A	X Walk 2 Width (in)	.0 11 <u>-</u> 111.0
Street 1 Name	SCOTT AV	•			X Walk 1 Slope (%)	1.2		X Walk 2 Slope (%)	3.8
Stop Condition-Street 2	Signal				X Walk 1 X Slope (%)	0.7		X Walk 2 X Slope (%)	0.1
Street 2 Name	EAST BV			N/A	Ramp inside XWalk1?	Yes	N/A	Ramp inside XWalk2?	Yes
Stop Condition-Street 1				N/A	Road Slope (%)	0.2	N/A	Clear Space?	N/A
Stop Condition-Street 1	Signal				,	0.2	N/A		
					Road X Slope (%)			Clear Space to XWalk (in)	N/A
