Access Compliance Report

Public Rights-of-Way

(Curb Ramps)

Intersection ID: 15013	Main Street: E_WORTHINGTON_AV	Cross Street: EWING_AV	Location:	S
ADA ID: B357939C7C19	Ramp Type: Perp	Initial Pass/Fail: Fail	Overall Compliance: No	Severity Score: 1.25
Codes/Mitigation Info/Possible Solution		Field Measurements/Component Compliance

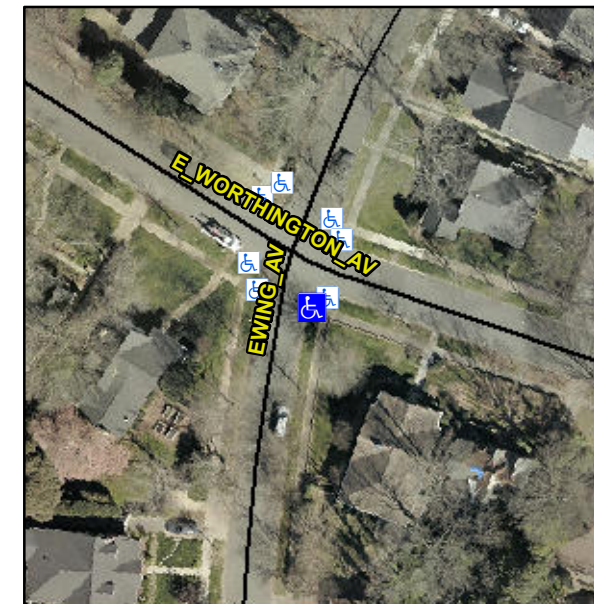
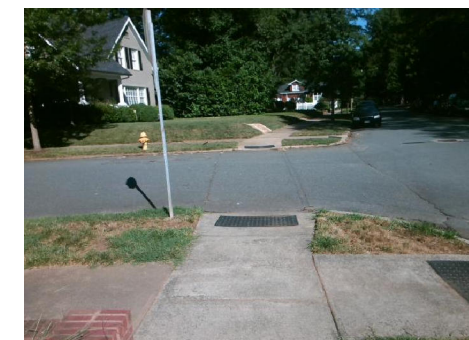
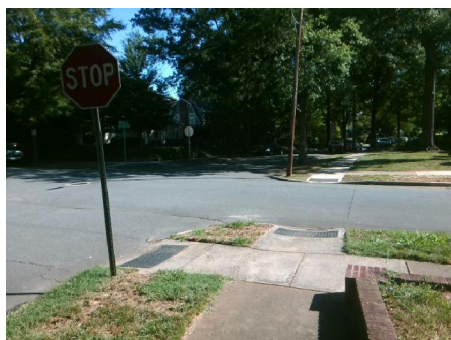
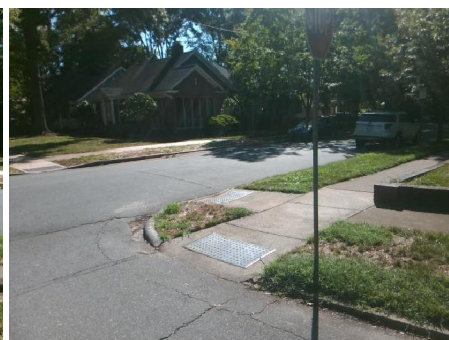
Compliance	Description	Data	Compliance	Description	Data
N/A	Ramp Length (in)	70.0	Yes	Ramp Slope (%)	6.7
Yes	Ramp Width (in)	48.0	No	Ramp XSlope (%)	4.3
N/A	Flare Type LT	N/A	N/A	Flare Type RT	N/A
N/A	Flare Slope LT (%)	N/A	N/A	Flare Slope RT (%)	N/A
N/A	Flare Traversable LT?	N/A	N/A	Flare Traversable RT?	N/A
N/A	Landing Length (in)	N/A	N/A	DWS Provided?	N/A
N/A	Landing Width (in)	N/A	N/A	DWS Contrast?	N/A
N/A	Landing Slope (%)	N/A	N/A	DWS Length (in)	N/A
N/A	Landing X Slope (%)	N/A	N/A	DWS Full Width?	N/A
N/A	Landing Curb? (Y/N)	N/A	N/A	DWS Offset (in)	N/A
N/A	Shared Landing?	N/A			
N/A	Gutter Ponding?	N/A	N/A	Gutter Slope (%)	N/A
N/A	Gutter Lip Ht (in)	N/A	N/A	Gutter X Slope (%)	N/A
N/A	Painted X Walk1?	No	N/A	Painted X Walk2?	N/A
	X Walk 1 Direction	To NW		X Walk 2 Direction	N/A
N/A	X Walk 1 Width (in)	N/A	N/A	X Walk 2 Width (in)	N/A
	X Walk 1 Slope (%)	4.0		X Walk 2 Slope (%)	N/A
	X Walk 1 X Slope (%)	0.9		X Walk 2 X Slope (%)	N/A

N/A	Ramp inside XWalk1?	N/A	N/A	Ramp inside XWalk2?	N/A
	Road Slope (%)	N/A	N/A	Clear Space?	N/A
	Road X Slope (%)	N/A	N/A	Clear Space to XWalk (in)	N/A
N/A	Any Obstructions?	N/A	N/A	Storm Grate/Utility Hazard?	N/A
	Obstruction Type			Storm Grate/Utility Type	
		N/A			N/A
			Yes	Surface Condition? (G/P)	Good

Possible Solutions:

Remove & Replace Entire Ramp.

R304.5.3
