Access Compliance Report

Public Rights-of-Way

(Curb Ramps)

Intersection ID: 27333	Main Street: BALLANTYNE_MEDICAL_PL	Cross Street: N/A	Location: SE
ADA ID: B35D05246A2E	Ramp Type: Perp	Initial Pass/Fail: Fail	Overall Compliance: No
Codes/Mitigation Info/Possible Solution		Field Measurements/Component Compliance	
Severity Score: 13.75

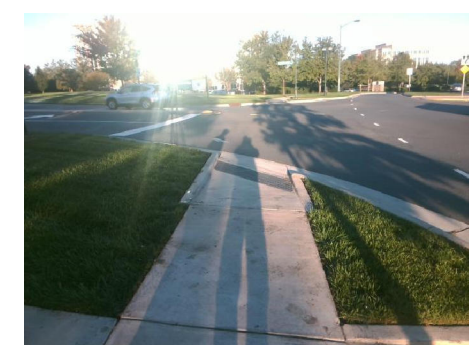
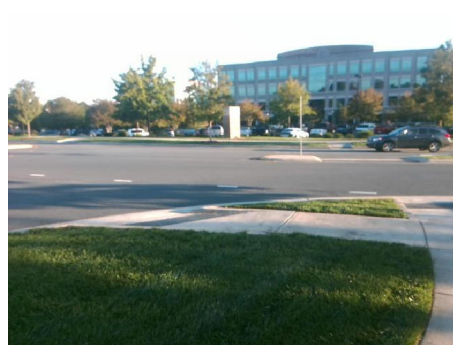
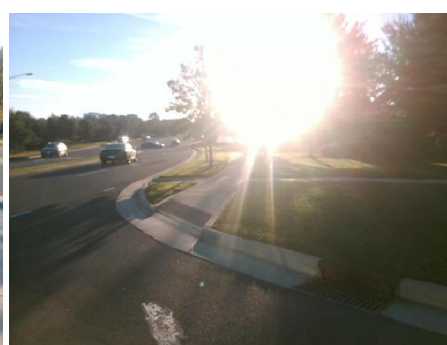
Not Found, R304.2.2, R304.5.3

Compliance	Description	Data	Compliance	Description	Data
N/A	Ramp Length (in)	81.0	No	Ramp Slope (%)	10.6
Yes	Ramp Width (in)	59.0	No	Ramp XSlope (%)	2.8
N/A	Flare Type LT	N/A	N/A	Flare Type RT	N/A
N/A	Flare Slope LT (%)	N/A	N/A	Flare Slope RT (%)	N/A
N/A	Flare Traversable LT?	N/A	N/A	Flare Traversable RT?	N/A
N/A	Landing Length (in)	N/A	N/A	DWS Provided?	N/A
N/A	Landing Width (in)	N/A	N/A	DWS Contrast?	N/A
N/A	Landing Slope (%)	N/A	N/A	DWS Length (in)	N/A
N/A	Landing X Slope (%)	N/A	N/A	DWS Full Width?	N/A
N/A	Landing Curb? (Y/N)	N/A	N/A	DWS Offset (in)	N/A
N/A	Shared Landing?	N/A			
N/A	Gutter Ponding?	N/A	N/A	Gutter Slope (%)	N/A
N/A	Gutter Lip Ht (in)	N/A	N/A	Gutter X Slope (%)	N/A
N/A	Painted X Walk1?	No	N/A	Painted X Walk2?	N/A
	X Walk 1 Direction	To W		X Walk 2 Direction	N/A
N/A	X Walk 1 Width (in)	N/A	N/A	X Walk 2 Width (in)	N/A
	X Walk 1 Slope (%)	0.4		X Walk 2 Slope (%)	N/A
	X Walk 1 X Slope (%)	3.7		X Walk 2 X Slope (%)	N/A

N/A	Ramp inside XWalk1?	N/A	N/A	Ramp inside XWalk2?	N/A
	Road Slope (%)	N/A	N/A	Clear Space?	N/A
	Road X Slope (%)	N/A	N/A	Clear Space to XWalk (in)	N/A
N/A	Any Obstructions?	N/A	N/A	Storm Grate/Utility Hazard?	N/A
	Obstruction Type			Storm Grate/Utility Type	
		N/A			N/A
		Yes		Surface Condition? (G/P)	Good

Remove & Replace Entire Ramp.

Total Cost: \$ 1850.00
