# Access Compliance Report

## Public Rights-of-Way

### (Curb Ramps)

| Intersection ID: N/A | Main Street: LONGSPUR_DR | Cross Street: PAINTED_TRILLIUM_CT | Location: SE |

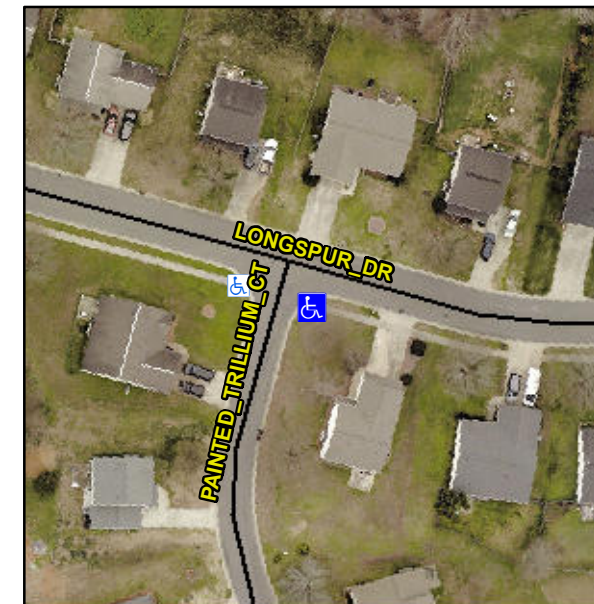
| ADA ID: B36550951BF1 | Ramp Type: PerpDiag | Initial Pass/Fail: Fail | Overall Compliance: No |
| Severity Score: 50 | | | |

**Not Found, R304.2.2, R304.5.3**

| Compliance | Description | Data | Compliance | Description | Data |
|---|---|---|---|---|---|
| N/A | Ramp Length (in) | 50.0 | No | Ramp Slope (%) | 12.2 |
| Yes | Ramp Width (in) | 48.0 | No | Ramp XSlope (%) | 8.9 |

**Remove & Replace Curb Ramp With Two New Directional Ramps or Equivalent.**

Total Cost: \$ 3200.00
