# Access Compliance Report

## Public Rights-of-Way

### (Curb Ramps)

Intersection ID: 11707	Main Street: N_GRAHAM_ST	Cross Street: W_6TH_ST	Location: S
ADA ID: B3705683E6B6	Ramp Type: PerpDiag	Initial Pass/Fail: Fail	Overall Compliance: No
Severity Score: 25			
Codes/Mitigation Info/Possible Solution		Field Measurements/Component Compliance

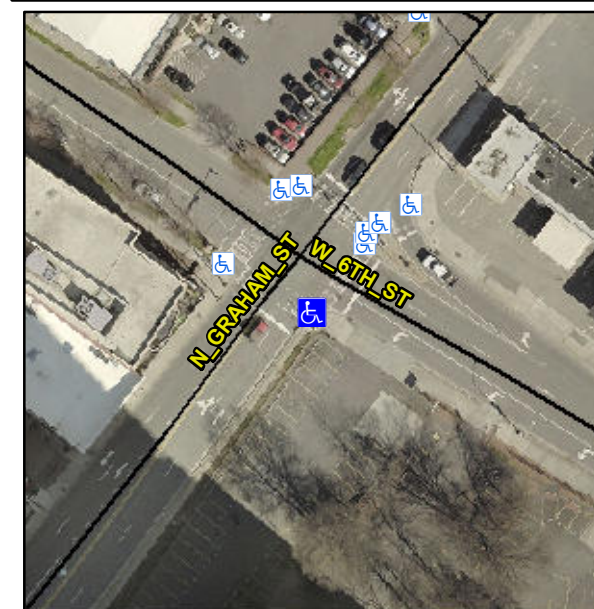
**Not Found, R304.2.2, R304.5.3**

Compliance	Description	Data	Compliance	Description	Data
N/A	Ramp Length (in)	91.0	No	Ramp Slope (%)	9.4
Yes	Ramp Width (in)	115.0	No	Ramp XSlope (%)	5.1
N/A	Flare Type LT	N/A	N/A	Flare Type RT	N/A
N/A	Flare Slope LT (%)	N/A	N/A	Flare Slope RT (%)	N/A
N/A	Flare Traversable LT?	N/A	N/A	Flare Traversable RT?	N/A
N/A	Landing Length (in)	N/A	N/A	DWS Provided?	N/A
N/A	Landing Width (in)	N/A	N/A	DWS Contrast?	N/A
N/A	Landing Slope (%)	N/A	N/A	DWS Length (in)	N/A
N/A	Landing X Slope (%)	N/A	N/A	DWS Full Width?	N/A
N/A	Landing Curb? (Y/N)	N/A	N/A	DWS Offset (in)	N/A
N/A	Shared Landing?	N/A			
N/A	Gutter Ponding?	N/A	N/A	Gutter Slope (%)	N/A
N/A	Gutter Lip Ht (in)	N/A	N/A	Gutter X Slope (%)	N/A
N/A	Painted X Walk1?	Yes	N/A	Painted X Walk2?	Yes
	X Walk 1 Direction	To NE		X Walk 2 Direction	To NW
N/A	X Walk 1 Width (in)	80.0	N/A	X Walk 2 Width (in)	110.0
	X Walk 1 Slope (%)	0.8		X Walk 2 Slope (%)	4.2
	X Walk 1 X Slope (%)	2.8		X Walk 2 X Slope (%)	1.1

N/A	Ramp inside XWalk1?	Yes	N/A	Ramp inside XWalk2?	Yes
	Road Slope (%)	4.5	N/A	Clear Space?	N/A
	Road X Slope (%)	3.2	N/A	Clear Space to XWalk (in)	N/A
N/A	Any Obstructions?	N/A	N/A	Storm Grate/Utility Hazard?	N/A
	Obstruction Type			Storm Grate/Utility Type	
		N/A			N/A
		Yes		Surface Condition? (G/P)	Good

**Remove & Replace Curb Ramp With Two New Directional Ramps or Equivalent.**
