Access Compliance Report

Public Rights-of-Way

(Curb Ramps)

Intersection ID: 21209	Main Street: GALLERIA_BV	Cross Street: SARDIS_RD_NORTH	Location:	N
ADA ID: B378F302BDA4	Ramp Type: Perp	Initial Pass/Fail: Fail	Overall Compliance: No	Severity Score: 10
Codes/Mitigation Info/Possible Solution		Field Measurements/Component Compliance

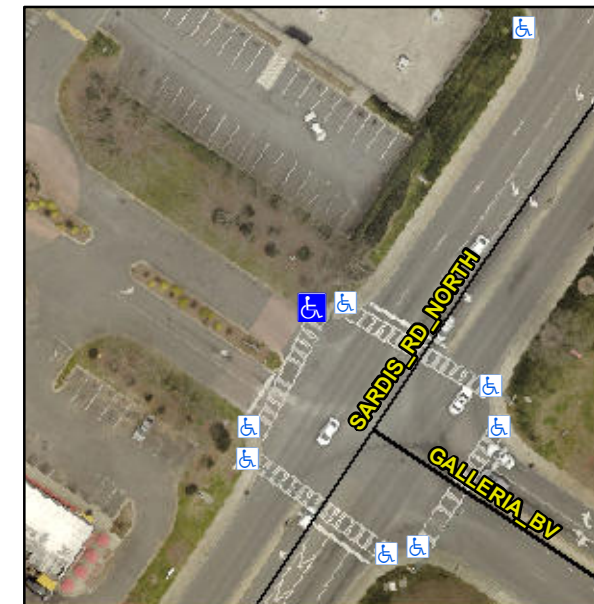
Compliance	Description	Data	Compliance	Description	Data
N/A	Ramp Length (in)	60.0	Yes	Ramp Slope (%)	6.8
No	Ramp Width (in)	39.0	No	Ramp XSlope (%)	3.3
N/A	Flare Type LT	N/A	N/A	Flare Type RT	N/A
N/A	Flare Slope LT (%)	N/A	N/A	Flare Slope RT (%)	N/A
N/A	Flare Traversable LT?	N/A	N/A	Flare Traversable RT?	N/A
N/A	Landing Length (in)	N/A	N/A	DWS Provided?	N/A
N/A	Landing Width (in)	N/A	N/A	DWS Contrast?	N/A
N/A	Landing Slope (%)	N/A	N/A	DWS Length (in)	N/A
N/A	Landing X Slope (%)	N/A	N/A	DWS Full Width?	N/A
N/A	Landing Curb? (Y/N)	N/A	N/A	DWS Offset (in)	N/A
N/A	Shared Landing?	N/A			
N/A	Gutter Ponding?	N/A	N/A	Gutter Slope (%)	N/A
N/A	Gutter Lip Ht (in)	N/A	N/A	Gutter X Slope (%)	N/A
N/A	Painted X Walk1?	Yes	N/A	Painted X Walk2?	N/A
	X Walk 1 Direction	To SW		X Walk 2 Direction	N/A
N/A	X Walk 1 Width (in)	108.0	N/A	X Walk 2 Width (in)	N/A
	X Walk 1 Slope (%)	4.7		X Walk 2 Slope (%)	N/A
	X Walk 1 X Slope (%)	0.1		X Walk 2 X Slope (%)	N/A

N/A	Ramp inside XWalk1?	Yes	N/A	Ramp inside XWalk2?	N/A
	Road Slope (%)	N/A	N/A	Clear Space?	N/A
	Road X Slope (%)	N/A	N/A	Clear Space to XWalk (in)	N/A
N/A	Any Obstructions?	N/A	N/A	Storm Grate/Utility Hazard?	N/A
	Obstruction Type			Storm Grate/Utility Type	
		N/A			N/A
		Yes		Surface Condition? (G/P)	Good

Possible Solutions:

Remove & Replace Entire Ramp.

R304.5.1, R304.5.3
