# Access Compliance Report

## Public Rights-of-Way

### (Curb Ramps)

Intersection ID: 15205	Main Street: CHEROKEE_RD	Cross Street: FENTON_PL	Location: NW
ADA ID: B37AF3132050	Ramp Type: Directional1	Initial Pass/Fail: Fail	Overall Compliance: No
Severity Score: 25			
Codes/Mitigation Info/Possible Solution		Field Measurements/Component Compliance

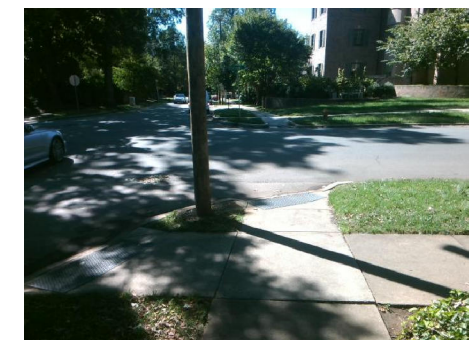
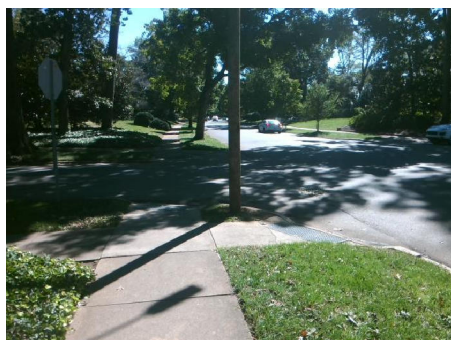
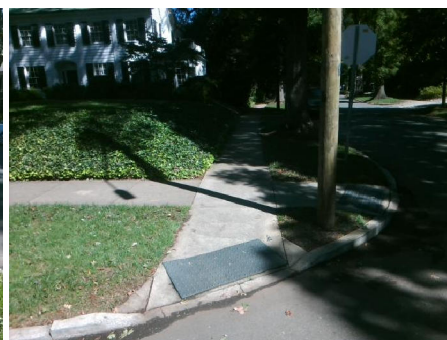
Compliance	Description	Data	Compliance	Description	Data
N/A	Ramp Length (in)	40.0	N/A	Grade Break?	N/A
Yes	Ramp Width (in)	51.0	N/A	Grade Break Slope (%)	0.0
No	Ramp Slope (%)	9.7	N/A	Grade Break XSlope (%)	0.0
No	Ramp XSlope (%)	5.2			
N/A	Flare Type LT	N/A	N/A	Flare Type RT	N/A
N/A	Flare Slope LT (%)	N/A	N/A	Flare Slope RT (%)	0.0
N/A	Flare Traversable LT?	N/A	N/A	Flare Traversable RT?	N/A
N/A	Landing Length (in)	0.0	N/A	DWS Provided?	N/A
N/A	Landing Width (in)	0.0	N/A	DWS Contrast?	N/A
N/A	Landing Slope (%)	0.0	N/A	DWS Length (in)	N/A
N/A	Landing X Slope (%)	0.0	N/A	DWS Full Width?	N/A
N/A	Landing Curb? (Y/N)	N/A	N/A	DWS Offset LT (in)	N/A
N/A	Shared Landing?	N/A	N/A	DWS Offset RT (in)	N/A
N/A	Gutter Ponding?	0.0	N/A	Gutter Slope (%)	N/A
N/A	Gutter Lip Ht (in)	0.0	N/A	Gutter X Slope (%)	N/A
N/A	Painted X Walk1?	No		Road Slope (%)	5.2
	X Walk 1 Direction	To SW		Road X Slope (%)	1.3
	X Walk 1 Width (in)	N/A		Clear Space?	N/A

X Walk 1 Slope (%)	5.2	N/A	Clear Space to XWalk (in)	N/A
	X Walk 1 X Slope (%)	1.3	N/A	Storm Grate/Utility Hazard?	N/A
N/A	Ramp inside XWalk1?	N/A		Storm Grate/Utility Type	
N/A	Any Obstructions?	N/A			N/A
	Obstruction Type		Yes	Surface Condition? (G/P)	Good
			N/A	Curb Slope (%)	14.4

**Remove & Replace Entire Ramp.**
