# Access Compliance Report

## Public Rights-of-Way

### (Curb Ramps)

Intersection ID: 27760	Main Street: BALLANTYNE_COUNTRY_CLUB_DR	Cross Street: BALLANTYNE_CROSSING_AV	Location: NW
ADA ID: B37C805320C7	Ramp Type: Perp	Initial Pass/Fail: Fail	Overall Compliance: No
Severity Score: 22.5			
Codes/Mitigation Info/Possible Solution		Field Measurements/Component Compliance

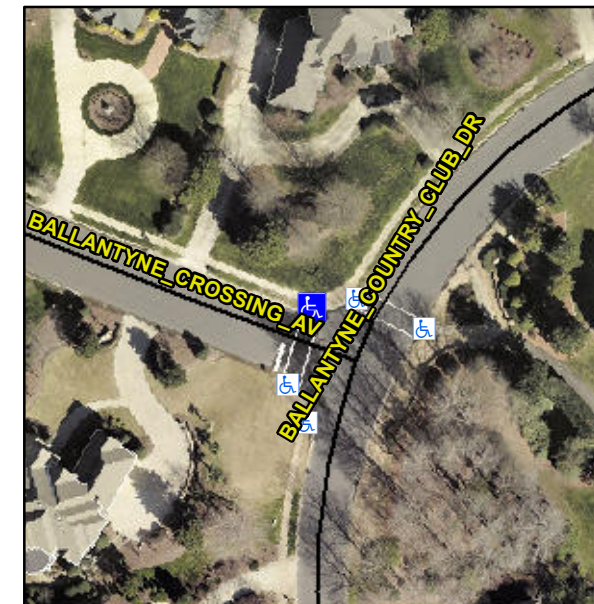
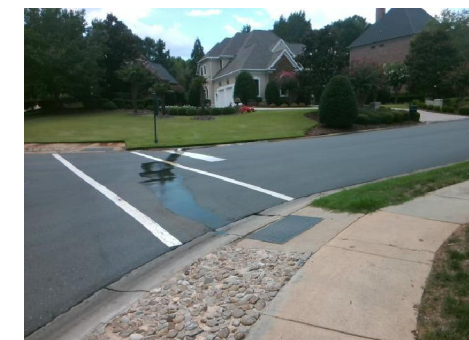
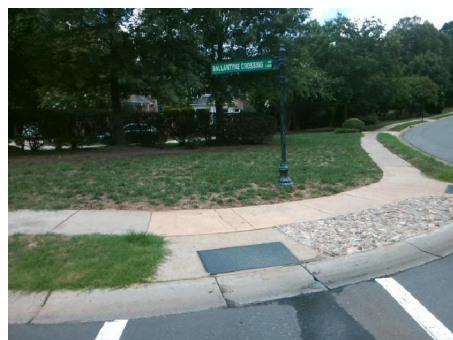
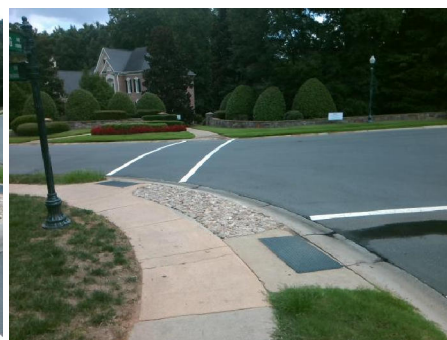
**Not Found, R304.5.1, R304.2.2, R304.5.3**

Compliance	Description	Data	Compliance	Description	Data
N/A	Ramp Length (in)	47.0	No	Ramp Slope (%)	8.9
No	Ramp Width (in)	43.0	No	Ramp XSlope (%)	4.6
N/A	Flare Type LT	N/A	N/A	Flare Type RT	N/A
N/A	Flare Slope LT (%)	N/A	N/A	Flare Slope RT (%)	N/A
N/A	Flare Traversable LT?	N/A	N/A	Flare Traversable RT?	N/A
N/A	Landing Length (in)	N/A	N/A	DWS Provided?	N/A
N/A	Landing Width (in)	N/A	N/A	DWS Contrast?	N/A
N/A	Landing Slope (%)	N/A	N/A	DWS Length (in)	N/A
N/A	Landing X Slope (%)	N/A	N/A	DWS Full Width?	N/A
N/A	Landing Curb? (Y/N)	N/A	N/A	DWS Offset (in)	N/A
N/A	Shared Landing?	N/A			
N/A	Gutter Ponding?	N/A	N/A	Gutter Slope (%)	N/A
N/A	Gutter Lip Ht (in)	N/A	N/A	Gutter X Slope (%)	N/A
N/A	Painted X Walk1?	Yes	N/A	Painted X Walk2?	N/A
	X Walk 1 Direction	To SW		X Walk 2 Direction	N/A
N/A	X Walk 1 Width (in)	102.0	N/A	X Walk 2 Width (in)	N/A
	X Walk 1 Slope (%)	6.2		X Walk 2 Slope (%)	N/A
	X Walk 1 X Slope (%)	1.6		X Walk 2 X Slope (%)	N/A

N/A	Ramp inside XWalk1?	Yes	N/A	Ramp inside XWalk2?	N/A
	Road Slope (%)	N/A	N/A	Clear Space?	N/A
	Road X Slope (%)	N/A	N/A	Clear Space to XWalk (in)	N/A
N/A	Any Obstructions?	N/A	N/A	Storm Grate/Utility Hazard?	N/A
	Obstruction Type			Storm Grate/Utility Type	
		N/A			N/A
			Yes	Surface Condition? (G/P)	Good

**Remove & Replace Entire Ramp.**

Total Cost: \$ 1850.00
