Access Compliance Report

Public Rights-of-Way

(Curb Ramps)

Intersection ID: 21358	Main Street: SARDIS_RD	Cross Street: SUMMERMORE_DR	Location: S
ADA ID: B3820BB5207C	Ramp Type: PerpDiag	Initial Pass/Fail: Fail	Overall Compliance: No
			Severity Score: 46.25

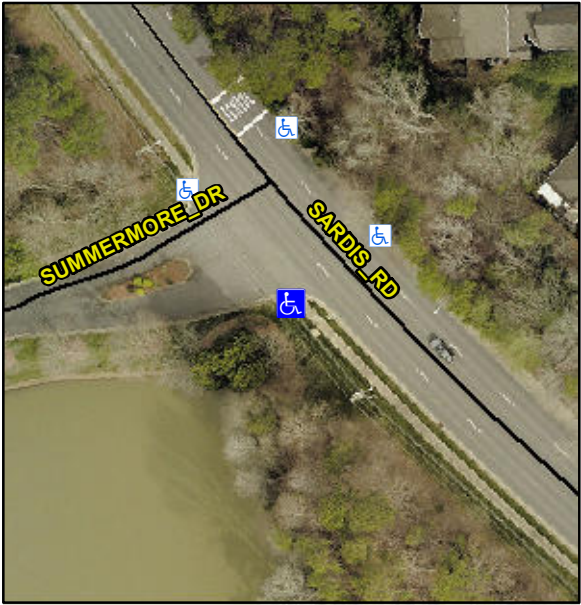
Possible Solutions:		Compliance	Description	Data
	Remove & Replace Curb Ramp With Two New Directional Ramps or Equivalent.		No	Ramp Length (in)	61.0
			No	Ramp Width (in)	38.0
			N/A	Flare Type LT	N/A
			N/A	Flare Slope LT (%)	N/A
			N/A	Flare Traversable LT?	N/A
			N/A	Landing Length (in)	N/A
			N/A	Landing Width (in)	N/A
			N/A	Landing Slope (%)	N/A
			N/A	Landing X Slope (%)	N/A
<p>Surveyor Notes:</p> <p>N/A</p> <p>PROW/ADA:</p> <p>R304.5.1, R304.2.2, R304.5.3</p>			N/A	Flare Type RT	N/A
			N/A	Flare Slope RT (%)	N/A
			N/A	Flare Traversable RT?	N/A
			N/A	DWS Provided?	N/A
			N/A	DWS Contrast?	N/A
			N/A	DWS Length (in)	N/A
			N/A	DWS Full Width?	N/A
			N/A	DWS Offset (in)	N/A
			N/A	Gutter Ponding?	N/A
			N/A	Gutter Lip Ht (in)	N/A
<p>Total Cost:</p> <p>\$ 3200.00</p>			No	Painted X Walk1?	No
				X Walk 1 Direction	To NE

N/A	X Walk 1 Width (in)	N/A
			3.6	X Walk 1 Slope (%)	3.1
			2.6	X Walk 1 X Slope (%)	0.0
			N/A	Ramp inside XWalk1?	N/A
			0.7	Road Slope (%)	N/A
			5.8	Road X Slope (%)	N/A
			N/A	Any Obstructions?	N/A
				Obstruction Type	
			N/A	Storm Grate/Utility Hazard?	N/A
			N/A	Storm Grate/Utility Type	N/A
			Yes	Surface Condition? (G/P)	Good
