# Access Compliance Report

## Public Rights-of-Way

### (Curb Ramps)

Intersection ID: 10579	Main Street: RUSH_AV	Cross Street: TUCKASEEGEE_RD	Location: NE
ADA ID: B38B1635B8A1	Ramp Type: Directional1	Initial Pass/Fail: Fail	Overall Compliance: No
			Severity Score: 21.25

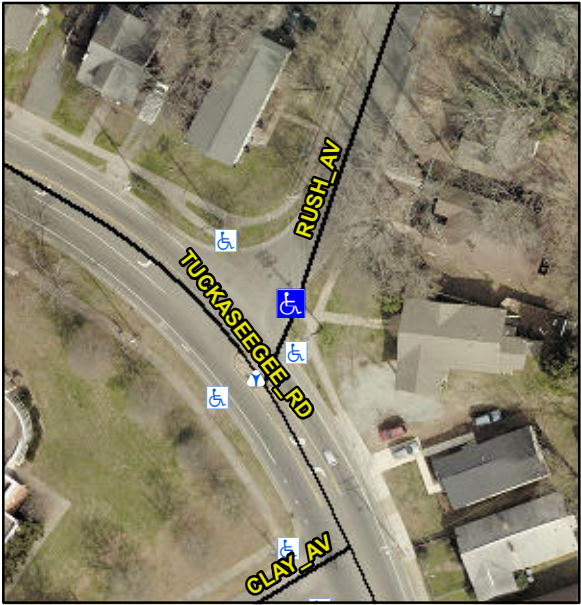
Possible Solutions:		<b>Compliance</b>	<b>Description</b>	<b>Data</b>	
	<b>Remove &amp; Replace Entire Ramp.</b>		<b>N/A</b>	Ramp Length (in)	<b>61.0</b>	<b>N/A</b>
			<b>No</b>	Ramp Width (in)	<b>47.5</b>	<b>N/A</b>
			<b>No</b>	Ramp Slope (%)	<b>9.0</b>	<b>N/A</b>
			<b>Yes</b>	Ramp XSlope (%)	<b>1.2</b>	
			<b>N/A</b>	Flare Type LT	<b>N/A</b>	<b>N/A</b>
			<b>N/A</b>	Flare Slope LT (%)	<b>N/A</b>	<b>N/A</b>
			<b>N/A</b>	Flare Traversable LT?	<b>N/A</b>	<b>N/A</b>
			<b>N/A</b>	Landing Length (in)	<b>0.0</b>	<b>N/A</b>
			<b>N/A</b>	Landing Width (in)	<b>0.0</b>	<b>N/A</b>
			<b>N/A</b>	Landing Slope (%)	<b>0.0</b>	<b>N/A</b>
			<b>N/A</b>	Landing X Slope (%)	<b>0.0</b>	<b>N/A</b>
			<b>N/A</b>	Landing Curb? (Y/N)	<b>N/A</b>	<b>N/A</b>
			<b>N/A</b>	Shared Landing?	<b>N/A</b>	<b>N/A</b>
			<b>N/A</b>	Gutter Ponding?	<b>0.0</b>	<b>N/A</b>

<b>N/A</b>	Gutter Lip Ht (in)	<b>0.0</b>	<b>N/A</b>
			<b>N/A</b>	Painted X Walk1?	<b>No</b>	
				X Walk 1 Direction	<b>To NW</b>	
				X Walk 1 Width (in)	<b>N/A</b>	
				X Walk 1 Slope (%)	<b>1.5</b>	<b>N/A</b>
				X Walk 1 X Slope (%)	<b>4.5</b>	<b>N/A</b>
			<b>N/A</b>	Ramp inside XWalk1?	<b>N/A</b>	
			<b>N/A</b>	Any Obstructions?	<b>N/A</b>	
				Obstruction Type		
					<b>Yes</b>	<b>Good</b>
					<b>N/A</b>	<b>12.4</b>
Surveyor Notes:						
<b>N/A</b>						
PROW/ADA:						
<b>R304.5.1, R304.2.2</b>						
Total Cost:			<b>\$</b>	<b>1600.00</b>
