Access Compliance Report

Public Rights-of-Way

(Curb Ramps)

Intersection ID: 12073	Main Street: E_11TH_ST	Cross Street: N_CALDWELL_ST	Location: W
ADA ID: B3932A8A0D79	Ramp Type: PerpDiag	Initial Pass/Fail: Fail	Overall Compliance: No
		Severity Score: 10

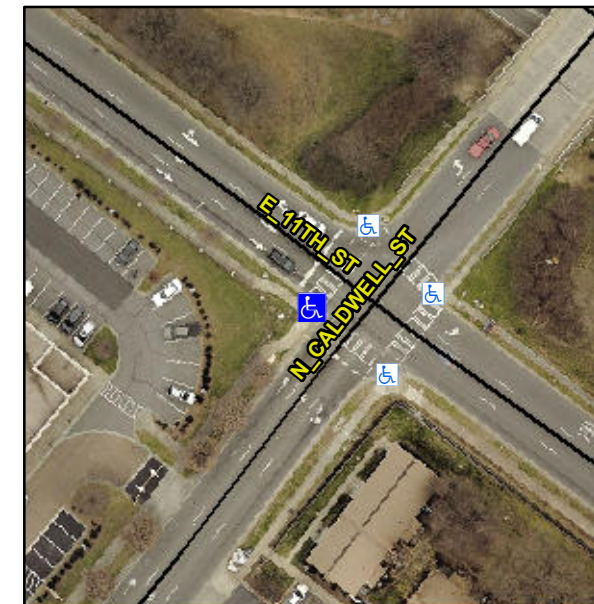
Not Found, R304.5.1, R304.5.3

Compliance	Description	Data	Compliance	Description	Data
N/A	Ramp Length (in)	57.0	Yes	Ramp Slope (%)	7.9
No	Ramp Width (in)	41.0	No	Ramp XSlope (%)	3.3
N/A	Flare Type LT	N/A	N/A	Flare Type RT	N/A
N/A	Flare Slope LT (%)	N/A	N/A	Flare Slope RT (%)	N/A
N/A	Flare Traversable LT?	N/A	N/A	Flare Traversable RT?	N/A
N/A	Landing Length (in)	N/A	N/A	DWS Provided?	N/A
N/A	Landing Width (in)	N/A	N/A	DWS Contrast?	N/A
N/A	Landing Slope (%)	N/A	N/A	DWS Length (in)	N/A
N/A	Landing X Slope (%)	N/A	N/A	DWS Full Width?	N/A
N/A	Landing Curb? (Y/N)	N/A	N/A	DWS Offset (in)	N/A
N/A	Shared Landing?	N/A			
N/A	Gutter Ponding?	N/A	N/A	Gutter Slope (%)	N/A
N/A	Gutter Lip Ht (in)	1.5	N/A	Gutter X Slope (%)	N/A
N/A	Painted X Walk1?	Yes	N/A	Painted X Walk2?	Yes
	X Walk 1 Direction	To SE		X Walk 2 Direction	To NE
N/A	X Walk 1 Width (in)	108.0	N/A	X Walk 2 Width (in)	112.0
	X Walk 1 Slope (%)	1.1		X Walk 2 Slope (%)	2.0
	X Walk 1 X Slope (%)	5.4		X Walk 2 X Slope (%)	3.2

N/A	Ramp inside XWalk1?	Yes	N/A	Ramp inside XWalk2?	Yes
	Road Slope (%)	0.2	N/A	Clear Space?	N/A
	Road X Slope (%)	3.7	N/A	Clear Space to XWalk (in)	N/A
N/A	Any Obstructions?	N/A	N/A	Storm Grate/Utility Hazard?	N/A
	Obstruction Type			Storm Grate/Utility Type	
		N/A			N/A
		Yes		Surface Condition? (G/P)	Good

Remove & Replace Curb Ramp With Two New Directional Ramps or Equivalent.
