# Access Compliance Report

## Public Rights-of-Way

### (Curb Ramps)

| Intersection ID: 3033 | Main Street: DEARMON_RD | Cross Street: BENFIELD_RD | Location: | N |

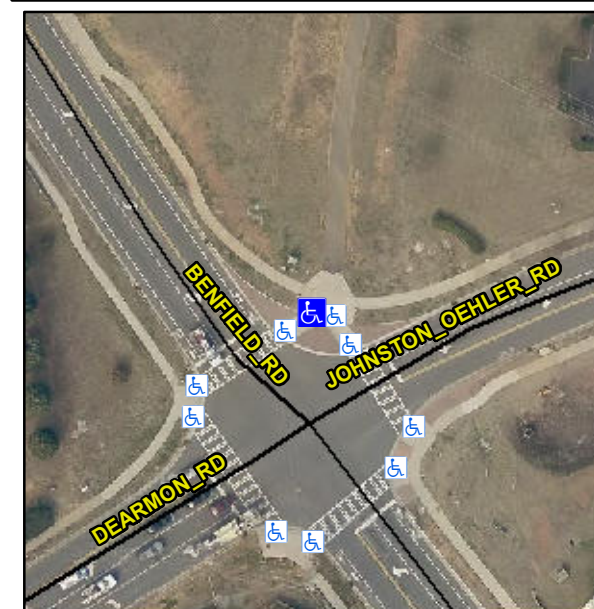
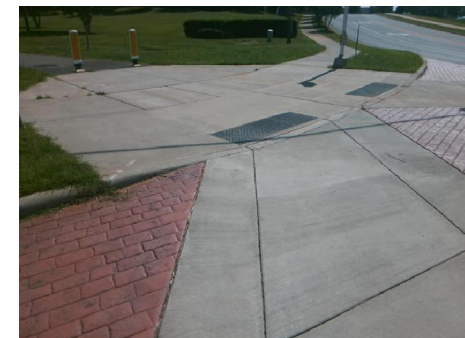
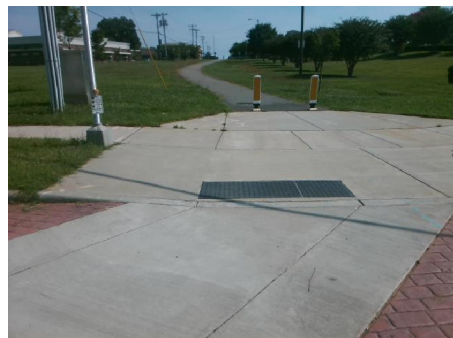
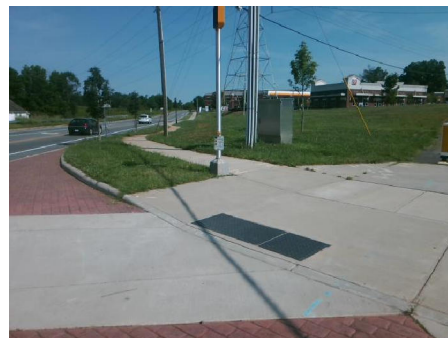
| ADA ID: B3992CBDB074 | Ramp Type: BlendTrans1 | Initial Pass/Fail: Pass | Overall Compliance: No | Severity Score: 0 |

**Not Found, R304.2.3, R305.2, R304.5.4, R304.5.3**

| Compliance | Description | Data | Compliance | Description | Data |
|---|---|---|---|---|---|
| N/A | Flare Slope LT (%) | 7.5 | No | Flare Slope RT (%) | N/A |
| N/A | Landing Curb? (Y/N) | No | No | DWS Offset (in) | 3.0 |
| | | | No | Curb Slope (%) | 12.7 |

**Remove & Replace Curb Ramp With Two New Directional Ramps or Equivalent. Remove & Replace Gutter.**
