Access Compliance Report

Public Rights-of-Way

(Curb Ramps)

Intersection ID: 18538	Main Street: SENECA_PL	Cross Street: SOUTH_BV	Location: SE
ADA ID: B39B7AF61365	Ramp Type: Perp	Initial Pass/Fail: Fail	Overall Compliance: No
Severity Score: 13.75			
Codes/Mitigation Info/Possible Solution		Field Measurements/Component Compliance

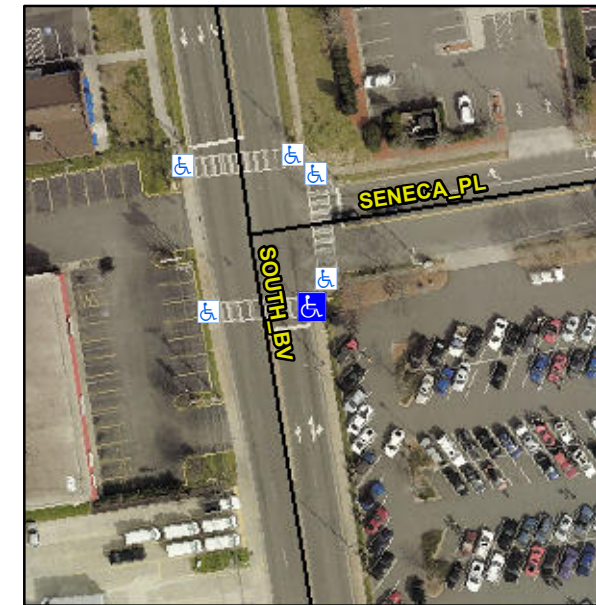
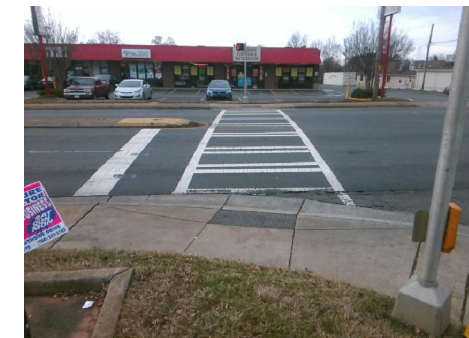
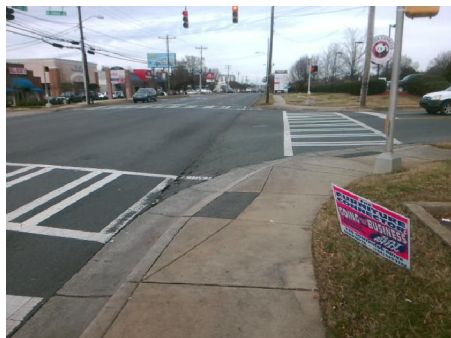
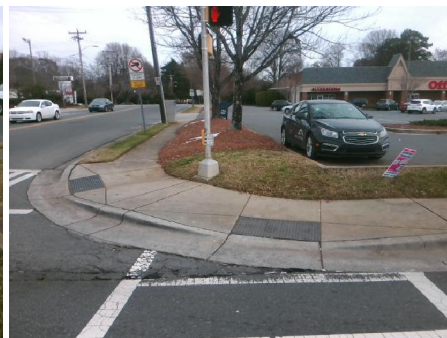
Not Found, R304.2.2, R304.5.3

Compliance	Description	Data	Compliance	Description	Data
N/A	Ramp Length (in)	68.0	No	Ramp Slope (%)	8.7
Yes	Ramp Width (in)	49.0	No	Ramp XSlope (%)	2.2
N/A	Flare Type LT	N/A	N/A	Flare Type RT	N/A
N/A	Flare Slope LT (%)	N/A	N/A	Flare Slope RT (%)	N/A
N/A	Flare Traversable LT?	N/A	N/A	Flare Traversable RT?	N/A
N/A	Landing Length (in)	N/A	N/A	DWS Provided?	N/A
N/A	Landing Width (in)	N/A	N/A	DWS Contrast?	N/A
N/A	Landing Slope (%)	N/A	N/A	DWS Length (in)	N/A
N/A	Landing X Slope (%)	N/A	N/A	DWS Full Width?	N/A
N/A	Landing Curb? (Y/N)	N/A	N/A	DWS Offset (in)	N/A
N/A	Shared Landing?	N/A			
N/A	Gutter Ponding?	N/A	N/A	Gutter Slope (%)	N/A
N/A	Gutter Lip Ht (in)	N/A	N/A	Gutter X Slope (%)	N/A
N/A	Painted X Walk1?	Yes	N/A	Painted X Walk2?	N/A
	X Walk 1 Direction	To W		X Walk 2 Direction	N/A
N/A	X Walk 1 Width (in)	107.0	N/A	X Walk 2 Width (in)	N/A
	X Walk 1 Slope (%)	5.1		X Walk 2 Slope (%)	N/A
	X Walk 1 X Slope (%)	1.0		X Walk 2 X Slope (%)	N/A

N/A	Ramp inside XWalk1?	Yes	N/A	Ramp inside XWalk2?	N/A
	Road Slope (%)	N/A	N/A	Clear Space?	N/A
	Road X Slope (%)	N/A	N/A	Clear Space to XWalk (in)	N/A
N/A	Any Obstructions?	N/A	N/A	Storm Grate/Utility Hazard?	N/A
	Obstruction Type			Storm Grate/Utility Type	
		N/A			N/A
		Yes		Surface Condition? (G/P)	Good

Remove & Replace Entire Ramp.

Total Cost: \$ 1850.00
