Access Compliance Report Public Rights-of-Way (Curb Ramps)

Intersection ID: 45688 Main Street: ALOYSIA_LN Cross Street: CANIPE_DR Location: S

ADA ID: B3A83D9800C0 Ramp Type: BlendTrans1 Initial Pass/Fail: Fail Overall Compliance: No Severity Score: 10

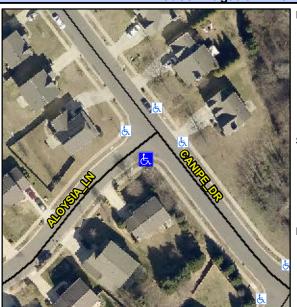
Not Found, R304.5.1, R304.5.3

Compliance Description		Data	Compliance Description		Data
N/A	Ramp Length (in)	48.0	Yes	BlendTrans Slope (%)	2.9
No	Ramp Width (in)	40.5	No	BlendTrans XSlope (%)	4.6
N/A	Flare Type LT	N/A	N/A	Flare Type RT	N/A
N/A	Flare Slope LT (%)	N/A	N/A	Flare Slope RT (%)	N/A
N/A	Flare Traversable LT?	N/A	N/A	Flare Traversable RT?	N/A
N/A	Landing Length (in)	N/A	N/A	DWS Provided?	N/A
N/A	Landing Width (in)	N/A	N/A	DWS Contrast?	N/A
N/A	Landing Slope (%)	N/A	N/A	DWS Length (in)	N/A
N/A	Landing X Slope (%)	N/A	N/A	DWS Full Width?	N/A
N/A	Landing Curb? (Y/N)	N/A	N/A	DWS Offset (in)	N/A
N/A	Shared Landing?	N/A			
N/A	Gutter Ponding?	N/A	N/A	Gutter Slope (%)	N/A
N/A	Gutter Lip Ht (in)	N/A	N/A	Gutter X Slope (%)	N/A
N/A	Painted X Walk1?	No	N/A	Painted X Walk2?	No
	X Walk 1 Direction	To NE		X Walk 2 Direction	To NW
	X Walk 1 Width (in)	N/A		X Walk 2 Width (in)	N/A
	X Walk 1 Slope (%)	4.2		X Walk 2 Slope (%)	6.9
	X Walk 1 X Slope (%)	5.5		X Walk 2 X Slope (%)	2.0

N/A	Ramp inside XWalk1?	N/A	N/A	Ramp inside XWalk2?	N/A
	Road Slope (%)	4.8		Clear Space?	N/A
	Road X Slope (%)	5.8	N/A	Clear Space to XWalk (in)	N/A
N/A	Any Obstructions?	N/A	N/A	Storm Grate/Utility Hazard?	N/A
	Obstruction Type		l	Storm Grate/Utility Type	
		N/A	l		N/A
			Yes	Surface Condition? (G/P)	Good
M _ #			No	Curb Slope (%)	18.9

Remove & Replace Curb Ramp With Two New Directional Ramps or Equivalent.
