Access Compliance Report Public Rights-of-Way (Curb Ramps)

Intersection ID: 20234 Main Street: SHOPTON RD WEST **Cross Street: WITHERS RD** Location: NW ADA ID: B3BDB3DEB0C8 **Overall Compliance: No** Severity Score: 26.25 Ramp Type: Combination1 Initial Pass/Fail: Fail

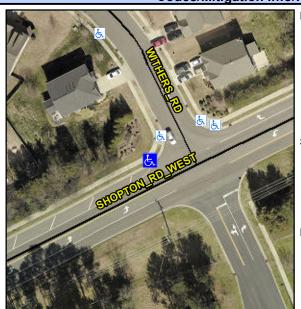
Compliance Description Possible Solutions: N/A Remove & Replace Entire Ramp. Yes Yes No N/A Yes Surveyor Notes: N/A N/A N/A N/A N/A N/A PROW/ADA: N/A R304.5.3, R304.3.2 N/A N/A N/A N/A
