# Access Compliance Report

## Public Rights-of-Way

### (Curb Ramps)

Intersection ID: 18176	Main Street: BRIARDALE_DR	Cross Street: MAPLECREST_DR	Location: NE
ADA ID: B3DDF36B2D0A	Ramp Type: PerpDiag	Initial Pass/Fail: Fail	Overall Compliance: No
Severity Score: 8.75			
Codes/Mitigation Info/Possible Solution		Field Measurements/Component Compliance

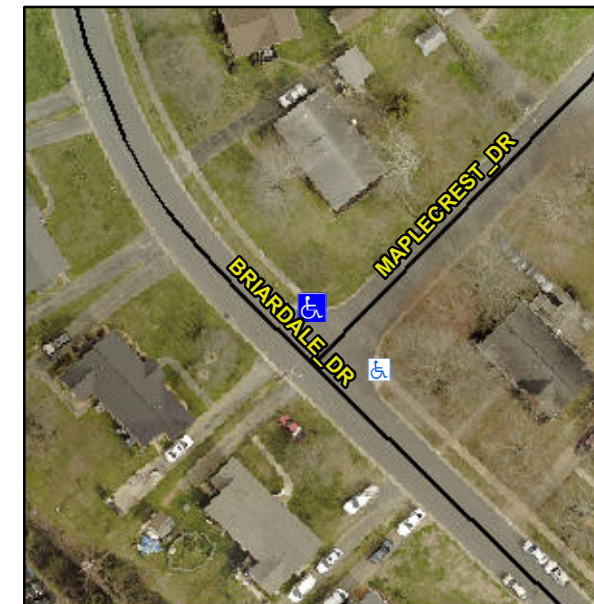
**Not Found, R304.5.1**

Compliance	Description	Data	Compliance	Description	Data
N/A	Ramp Length (in)	65.0	Yes	Ramp Slope (%)	5.2
No	Ramp Width (in)	46.5	Yes	Ramp XSlope (%)	1.7
N/A	Flare Type LT	N/A	N/A	Flare Type RT	N/A
N/A	Flare Slope LT (%)	N/A	N/A	Flare Slope RT (%)	N/A
N/A	Flare Traversable LT?	N/A	N/A	Flare Traversable RT?	N/A
N/A	Landing Length (in)	N/A	N/A	DWS Provided?	N/A
N/A	Landing Width (in)	N/A	N/A	DWS Contrast?	N/A
N/A	Landing Slope (%)	N/A	N/A	DWS Length (in)	N/A
N/A	Landing X Slope (%)	N/A	N/A	DWS Full Width?	N/A
N/A	Landing Curb? (Y/N)	N/A	N/A	DWS Offset (in)	N/A
N/A	Shared Landing?	N/A			
N/A	Gutter Ponding?	N/A	N/A	Gutter Slope (%)	N/A
N/A	Gutter Lip Ht (in)	N/A	N/A	Gutter X Slope (%)	N/A
N/A	Painted X Walk1?	No	N/A	Painted X Walk2?	No
	X Walk 1 Direction	To SW		X Walk 2 Direction	To SE
N/A	X Walk 1 Width (in)	N/A	N/A	X Walk 2 Width (in)	N/A
	X Walk 1 Slope (%)	4.8		X Walk 2 Slope (%)	1.0
	X Walk 1 X Slope (%)	1.1		X Walk 2 X Slope (%)	2.1

N/A	Ramp inside XWalk1?	N/A	N/A	Ramp inside XWalk2?	N/A
	Road Slope (%)	0.7	N/A	Clear Space?	N/A
	Road X Slope (%)	4.5	N/A	Clear Space to XWalk (in)	N/A
N/A	Any Obstructions?	N/A	N/A	Storm Grate/Utility Hazard?	N/A
	Obstruction Type			Storm Grate/Utility Type	
		N/A			N/A
			Yes	Surface Condition? (G/P)	Good

**Remove & Replace Curb Ramp With Two New Directional Ramps or Equivalent.**

Total Cost: \$ 3200.00
