Access Compliance Report

Public Rights-of-Way

(Curb Ramps)

Intersection ID: 21669		Main Street: CARMEL_RD		Cross Street: TOWN_ & COUNTRY_DR		Location: SW							
ADA ID: B3E8920BCA5D		Ramp Type: Directional1		Initial Pass/Fail: Fail		Overall Compliance: No		Severity Score: 10					
Codes/Mitigation Info/Possible Solution				Field Measurements/Component Compliance									
<div>

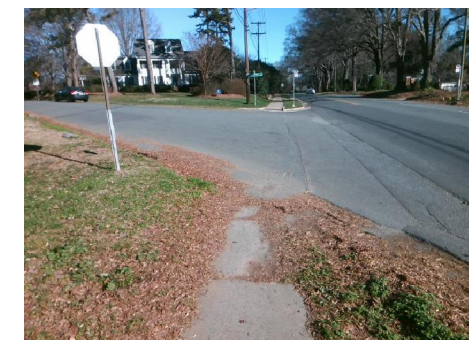
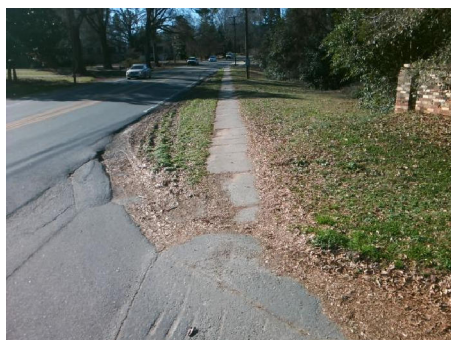
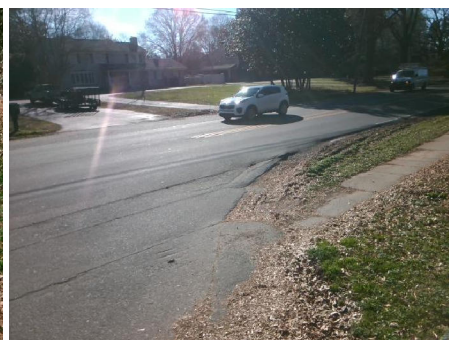
N/A	Landing Length (in)	0.0	N/A	DWS Provided?	N/A				
				N/A	Landing Width (in)	0.0	N/A	DWS Contrast?	N/A				
				N/A	Landing Slope (%)	0.0	N/A	DWS Length (in)	N/A				
				N/A	Landing X Slope (%)	0.0	N/A	DWS Full Width?	N/A				
				N/A	Landing Curb? (Y/N)	N/A	N/A	DWS Offset LT (in)	N/A				
				N/A	Shared Landing?	N/A	N/A	DWS Offset RT (in)	N/A				
				N/A	Gutter Ponding?	0.0	N/A	Gutter Slope (%)	N/A				
				N/A	Gutter Lip Ht (in)	0.0	N/A	Gutter X Slope (%)	N/A				
				N/A	Painted X Walk1?	No		Road Slope (%)	3.8				
					X Walk 1 Direction	To NE		Road X Slope (%)	3.6				
					X Walk 1 Width (in)	N/A		Clear Space?	N/A				
					X Walk 1 Slope (%)	3.8	N/A	Clear Space to XWalk (in)	N/A				
					X Walk 1 X Slope (%)	3.6	N/A	Storm Grate/Utility Hazard?	N/A				
				N/A	Ramp inside XWalk1?	N/A		Storm Grate/Utility Type					
				N/A	Any Obstructions?	N/A			N/A				
					Obstruction Type		Yes	Surface Condition? (G/P)	Good

N/A	Curb Slope (%)	5.8				
				Total Cost:				\$	1600.00

</div> <div>Possible Solutions:</div> <div>Remove & Replace Entire Ramp.</div> <div>Surveyor Notes:</div> <div>N/A</div> <div>PROW/ADA:</div> <div>R304.5.1, R304.5.3</div>				Compliance	Description	Data	Compliance	Description	Data				
				N/A	Ramp Length (in)	96.0	N/A	Grade Break?	N/A				
				No	Ramp Width (in)	42.0	N/A	Grade Break Slope (%)	0.0				
				Yes	Ramp Slope (%)	2.8	N/A	Grade Break XSlope (%)	0.0				
				No	Ramp XSlope (%)	4.8							
				N/A	Flare Type LT	N/A	N/A	Flare Type RT	N/A				
				N/A	Flare Slope LT (%)	N/A	N/A	Flare Slope RT (%)	0.0				
				N/A	Flare Traversable LT?	N/A	N/A	Flare Traversable RT?	N/A
